## Evaluation of a Turbocharger Turbine Wheel

J.L. McDougall \*, R.R. Knuteson \*, M.E. Stevenson \*, and F. E. Schmidt, Jr. \*\*

\* Engineering Systems Inc., 6230 Regency Parkway, Norcross, GA 30071

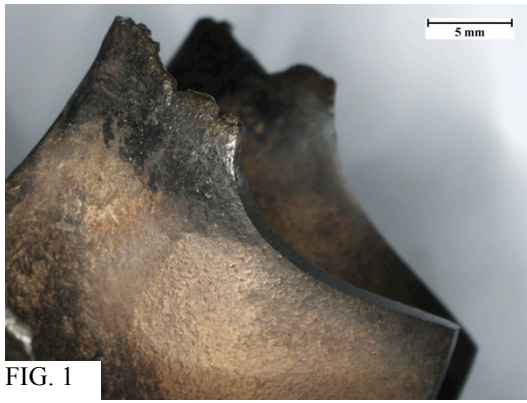
Visual examination of one of the turbocharger turbine wheel, revealed evidence of impact damage at the blade tips, a region where contact with the surrounding case would generally not occur. Energy dispersive spectroscopy (EDS) and phase mapping revealed evidence of FOD manifested in the presence of iron and chromium immediately adjacent to the blade damage. Visual examination of the turbine housing inlet revealed evidence of FOD in the form of impact damage on the interior surface. Metallographic evaluation revealed no evidence that the turbocharger turbine wheel was overheated.

FIG. 1. Optical Micrograph of turbocharger turbine wheel blade damage

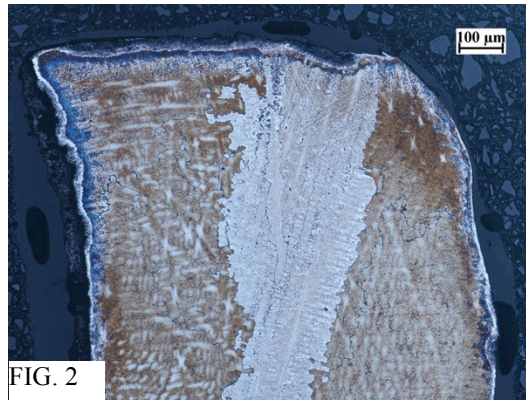
FIG. 2. Photomicrograph of undamaged turbine blade with no evidence of creep voids

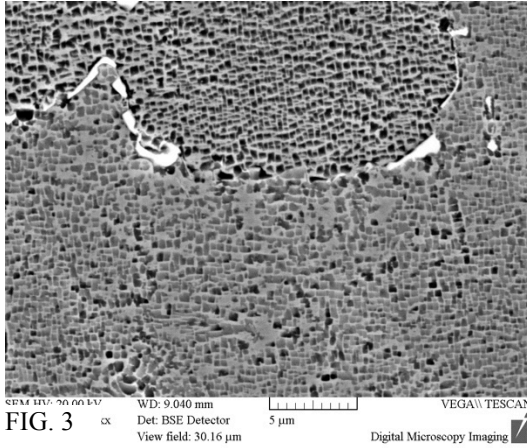
FIG. 3. SEM of metallographically prepared turbocharger blade (10,000x)

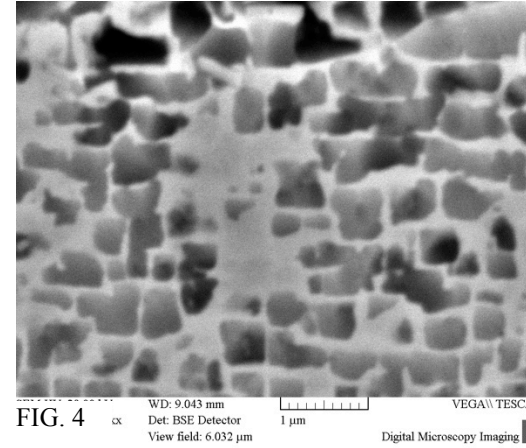
FIG. 4. SEM of metallographically prepared turbocharger blade (50,000x)

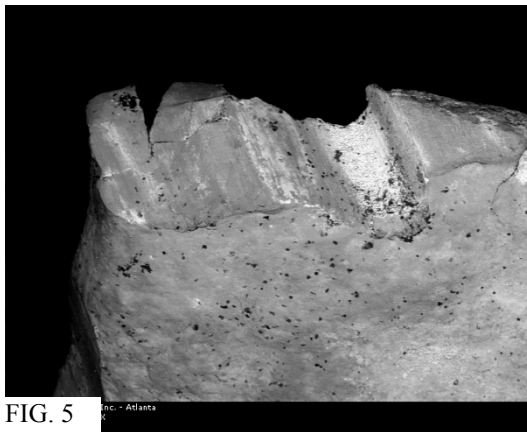
FIG. 5. SEM micrograph of damaged turbocharger turbine wheel blade (100x)

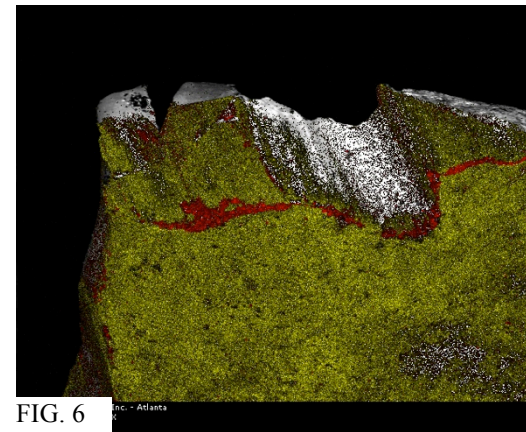
FIG. 6. Phase map with evidence of foreign material on damaged turbocharger blade (100x)

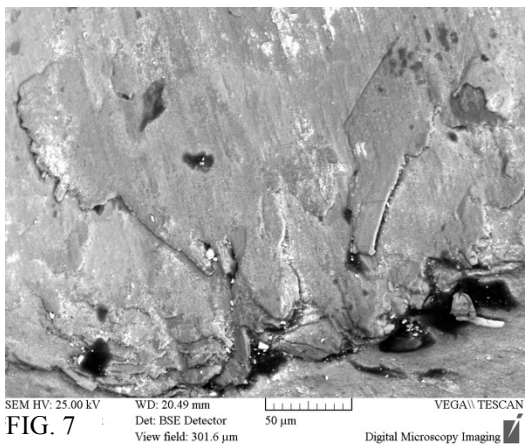
FIG. 7. SEM micrograph of damaged turbocharger turbine wheel blade (1000x)

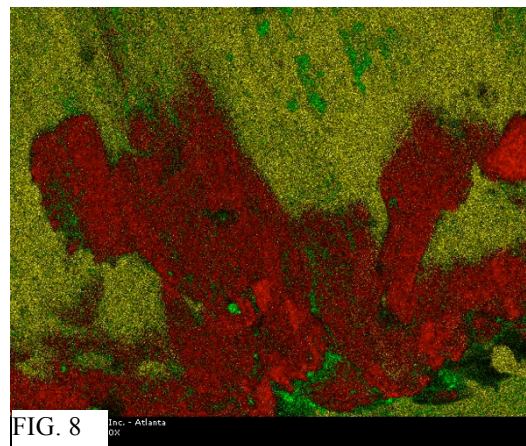
FIG. 8. Phase map with evidence of foreign material on damaged turbocharger blade (1000x)
