## Neoformations on stony materials of modern building works

C. Alves\*

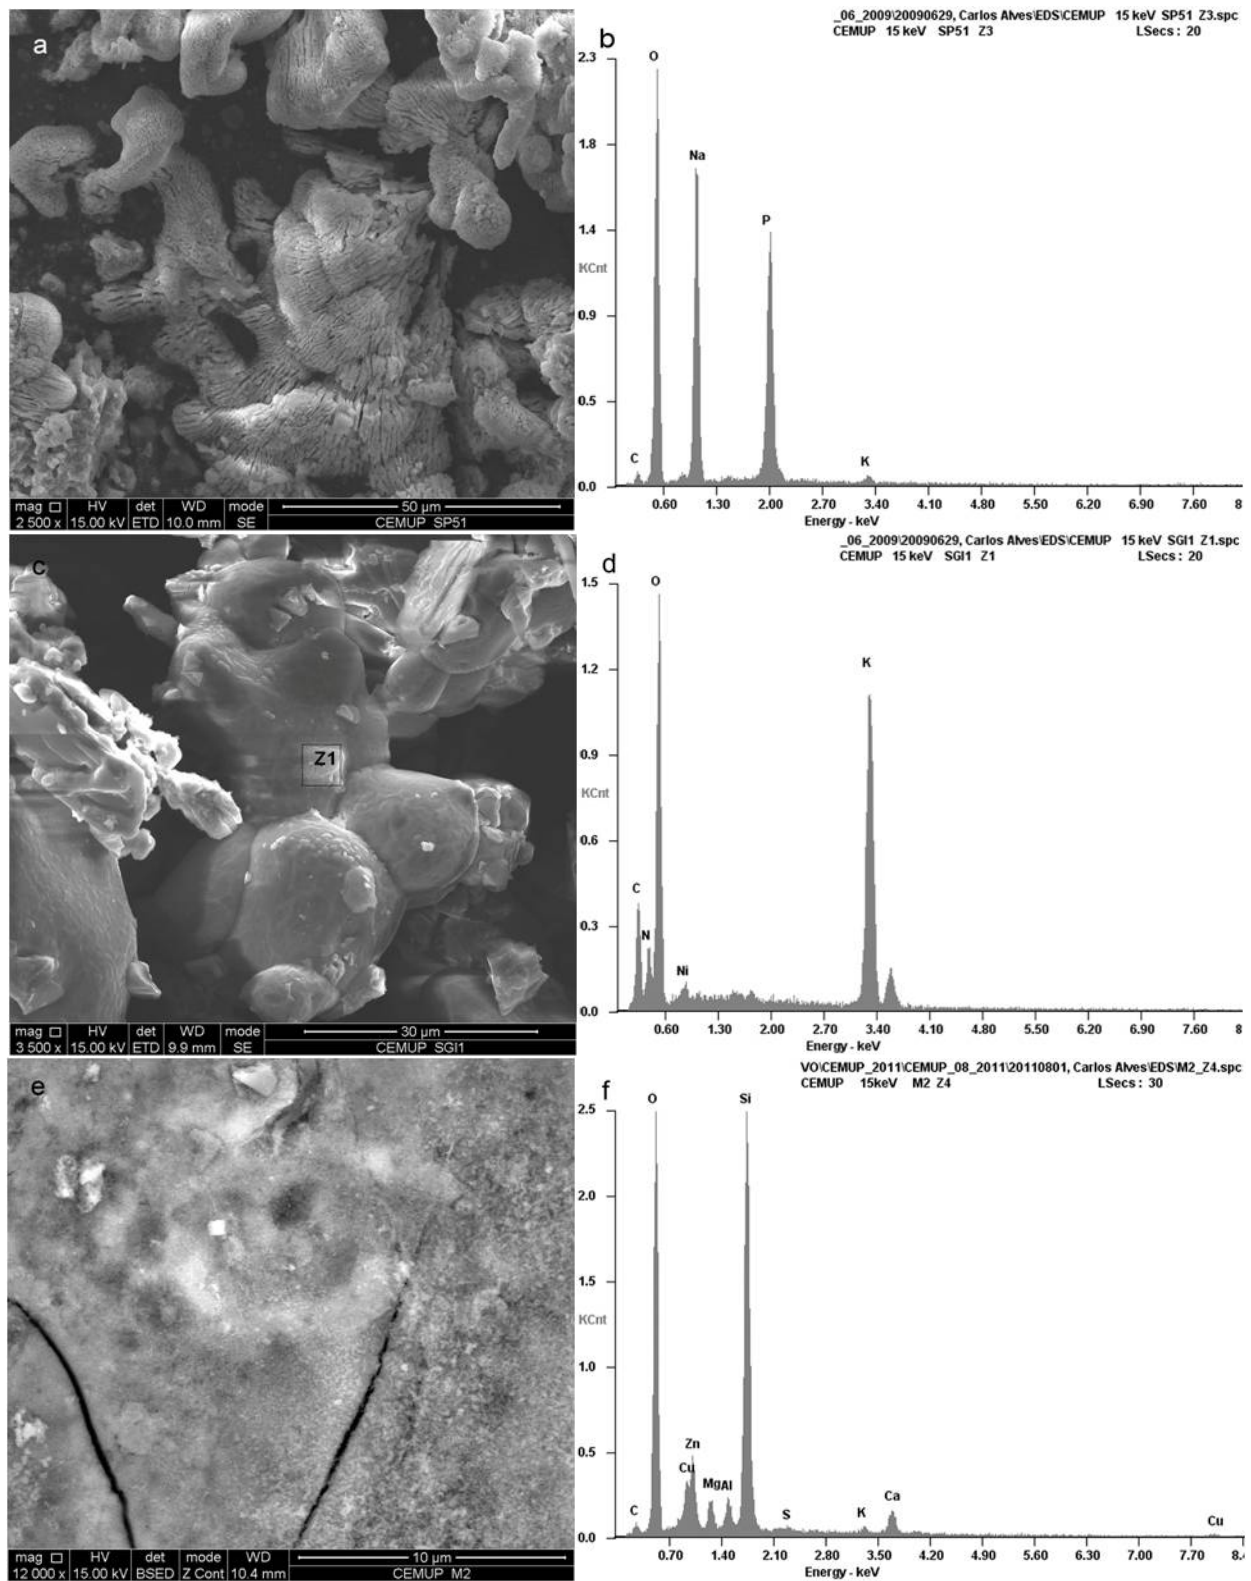
Fig. 1 – Neoformations in modern built works: a), b) phosphate aggregates; c),d) potassium nitrate; e),f) silica-rich stains. Analyses performed at CEMUP laboratory (University of Oporto, Portugal).
