Using SEM techniques for failure analysis of critical aeroengine components

J. M. Silva*, V. Infante** and A. S. Brito**

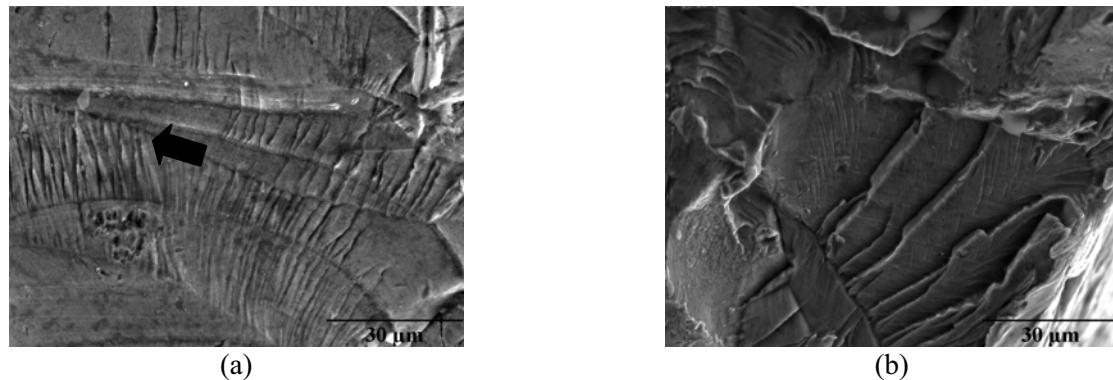
Fig.1 – SEM analysis of the fracture surface of a compressor blade; (a): striations due to cyclic plastic deformations related with fatigue mechanisms; (b): brittle fracture observed near the final fracture region.

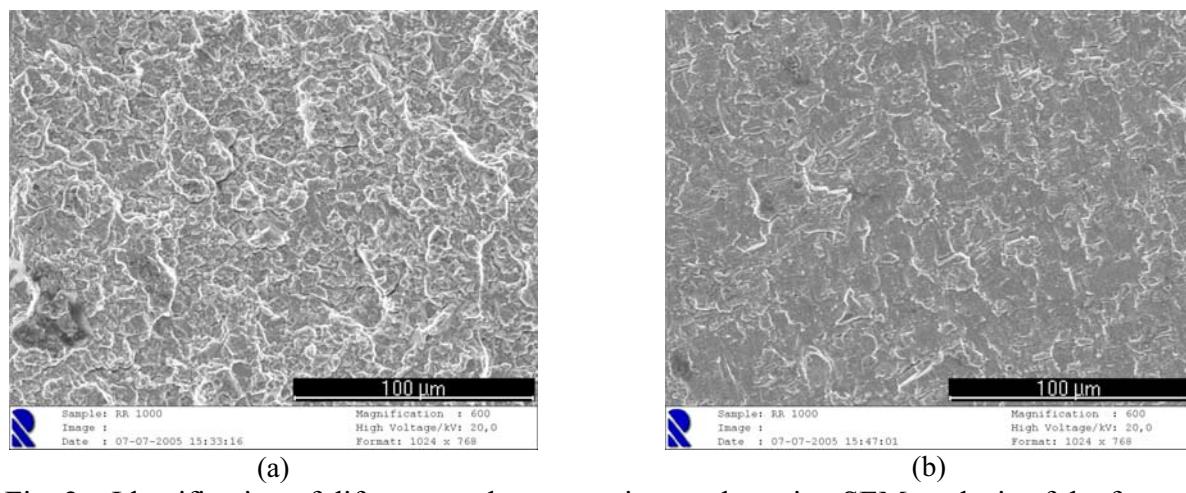
Fig. 2 – Identification of different crack propagation modes using SEM analysis of the fracture surface related with case B; (a): intergranular crack propagation; (b): transgranular crack propagation.
