Use of Microscopical Techniques in Failure Analysis and Defect Control in Automotive Castings

E. Velasco*, A. Rodríguez*, J.A. González*, J. Talamantes*, R. Colás** and S. Valtierra*

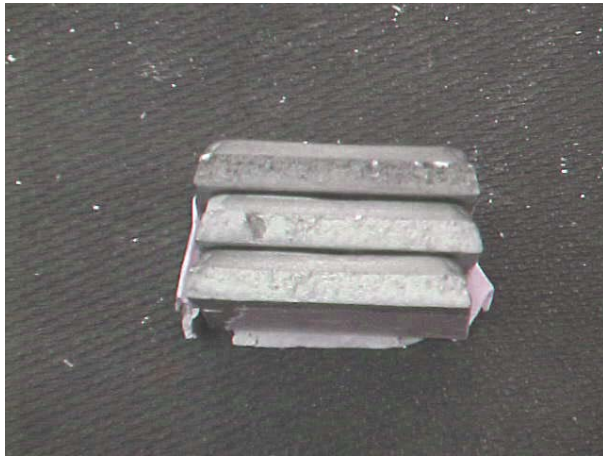
A series of cylinder block heads (CBH) were reported to leak while being tested under water. Visual inspection indicated that the origin of the problem was located towards the upper portion of the pieces, which were sectioned for their X-ray inspection and examination by optical microscopy (OM), the liquid metal was also tested for cleanliness. OM put in evidence the presence of thin oxide films within the cast pieces, Fig. 1, that are associated with the oxidation of turbulent flowing metal. Inspection of casting operation revealed that in some cases the metal was cascading into the mould, Fig. 2. Corrective actions were made in such cases and the defect was suppressed.

Fig. 1 Fracture surface of the piece with the defect.

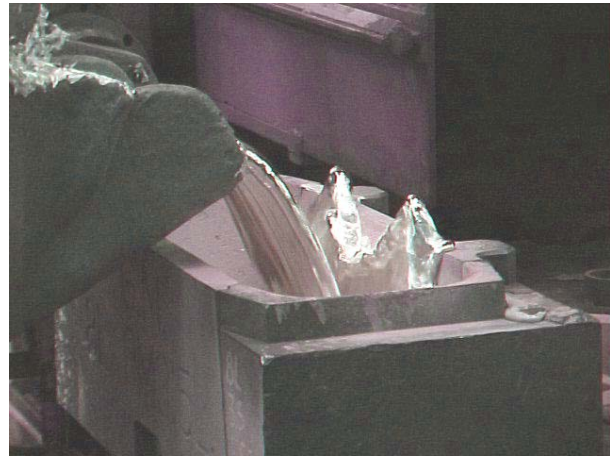
Fig. 2. Liquid cascading into the mould

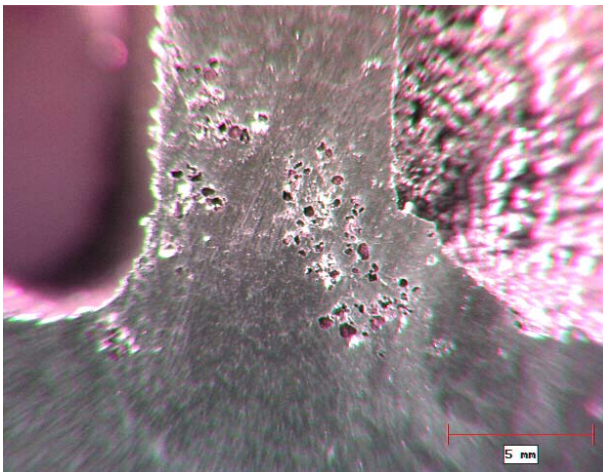
Some other CBH were found to leak when subjected to the water test. OM examination of these pieces indicated the presence of porosity close to the bottom portion of the piece, Fig. 3. Their roundness allowed to assume that these defects were caused by trapped gases, but the use of an image analyzer, in the false color mode, indicated the presence of sand grains within the pores, Fig. 4. It was concluded that the defect originated by sand that was carried away from cores and was trapped in thin walls. The grains did not allowed for the free flow of liquid metal into these walls and, the lack of adequate feeding, caused the occurrence of this defect. Actions were taken to assure the integrity of the cores, the use of higher resistant coatings and better care to the assembly of the moulds.

Fig. 3. Defects found in pieces.

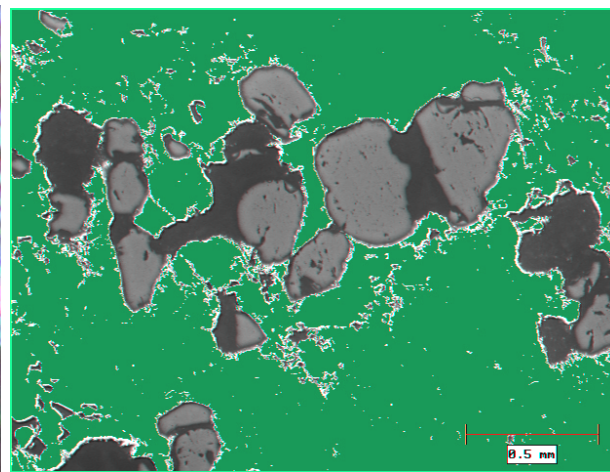
Fig. 4. Porosity detected in the piece.

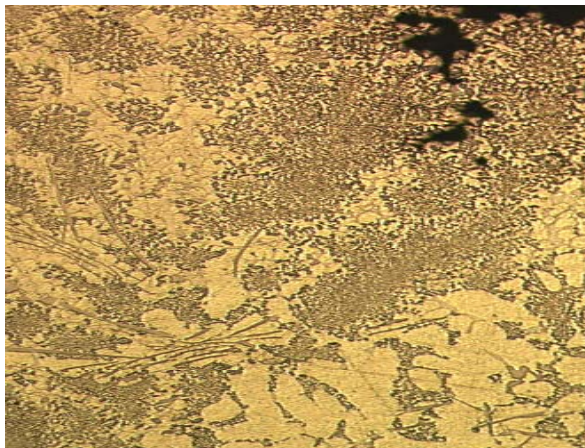
Some pieces were detected to be faulty while being machined, the pieces with the defect were sectioned to be analyzed by different techniques. It was observed that the defects appear towards the upper part of the piece. Microstructural analysis showed that some defects were caused metal flowing from different directions, whereas some others were associated with a series of bubbles caused by turbulence. This study resulted in the modification of the feeding system and in better care on the coating used to protect the mould.

Fig. 5. Microstructure of the zone with the defect.
