Characterization of Localized Degradation in Reverse-Biased GaN HEMTs by Scanning Transmission Electron Microscopy and Electron Holography

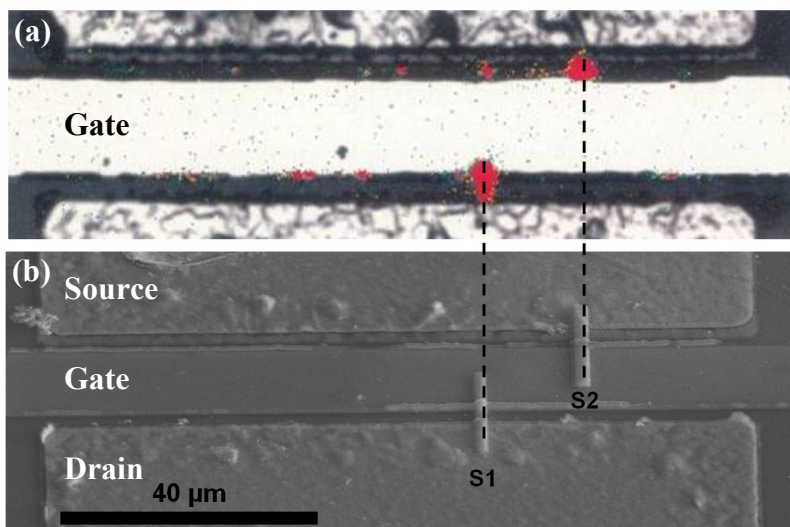
Figure 1. (a) EL image recorded during high-stress reverse biasing. Light emission occurred in localized regions at the gate edge where defects are believed to provide a leakage path for hot electrons. (b) SEM image of identical area; Pt bars were deposited over the localized hot spots in preparation for FIB cutting and subsequent lift-out.

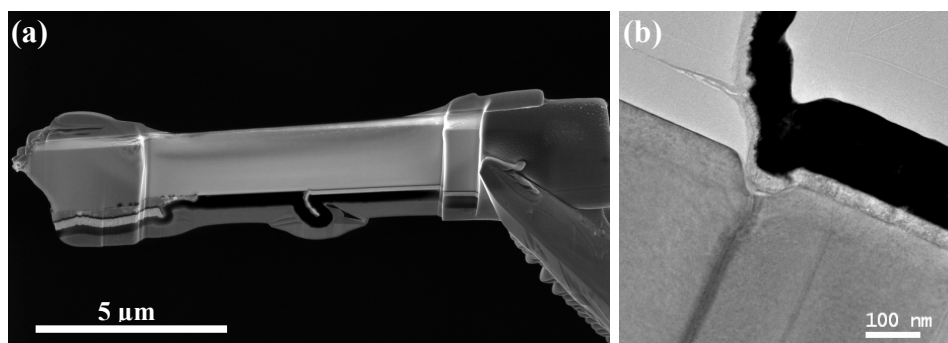
Figure 2. (a) SEM image of FIB lift-out specimen prepared from the region labeled S1 in Figure 1. The cross-section was mounted for backside milling using the Omniprobe short-cut press to avoid curtaining effects during FIB thinning. (b) Bright-field TEM image of the gate edge.
