Microstructural Analysis of the Steels from Buildings 7, & 1 or 2 from the World Trade Center

R. R. Biederman,* Erin M. Sullivan,* R. D. Sisson, Jr.,* and George F. Vander Voort**

*Materials Science & Engineering Program, Mechanical Engineering Department, Worcester Polytechnic Institute, Worcester, MA 01609-2280

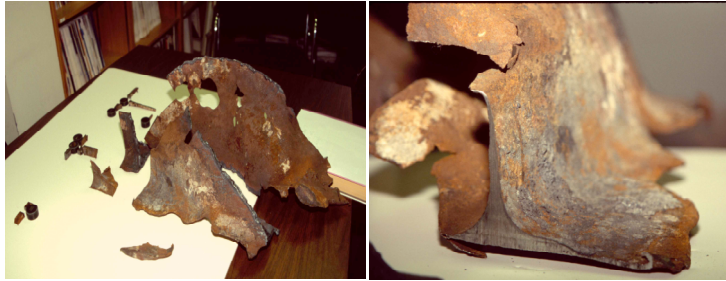
Several samples from Buildings 7, and 1 or 2 of the World Trade Center were collected during the FEMA forensic investigation shortly after September 11, 2001. Macroscopically these samples revealed severe “erosion” of the steel beam thickness from 1/2 inch to total metal loss in some regions, as well as localized plastic deformation. We were asked to determine the cause of this “erosion” as well the temperature that the steel experienced. Figure 1 shows typical examples of the severe erosion that occurred in the beam.

FIG. 1. Severely Eroded 1/2 inch wide flange beam from WTC 7.

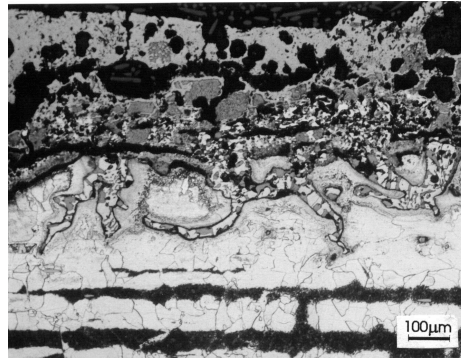
A microstructural analysis of these steel samples has been completed. In Building 7, the structural steel was A36. Figure 2 shows the near surface microstructural changes that occurred in the steel.

The as-fabricated microstructure consisted of a hot worked banded structure of ferrite and pearlite. In severely “eroded” regions where the thickness had been reduced to less than a 1/16 of an inch significant decarburization was observed. In addition, some pearlite bands presented regions that had re-austenitized as well as regions where the pearlite had started to spheroidize. These observations indicate that steel had experienced temperature between 550 and 850°C.

An examination of the “slag” that formed on the surface of the steel found iron oxides and iron sulfides. It appeared that the “slag” was liquid at high temperature and easily attacked the grain boundaries. A eutectic microstructure was seen within the “slag” of iron oxides and iron sulfides. If these compounds were pure wustite (FeO) and iron sulfide (FeS), the eutectic temperature is 940°C. It appears that the severe “erosion” was due to the sulfidation and oxidation (i.e., hot corrosion) of the steel followed by the liquid “slag” attack of the grain boundaries.

FIG. 2. Near surface oxidation and intergranular sulfidation.

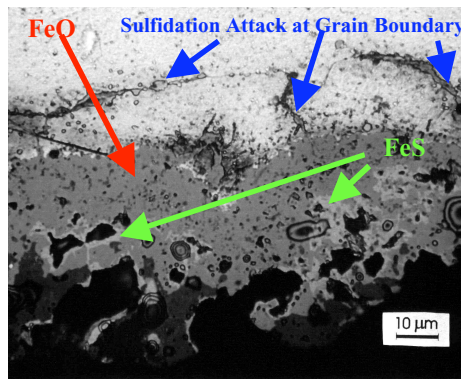
A sample from either Building 1 or 2 presented similar macroscopic observations. In these buildings, the steel was a high strength low alloy steel (HSLA). The microstructure revealed somewhat different phase distributions. This steel contained less carbon and an alloy addition of copper. The “slag” while comprised of both iron oxides and iron sulfides presented a significantly different microstructure near the surface as shown in Figure 3.

FIG. 3. Surface reaction region in WTC 1 or 2 column member.

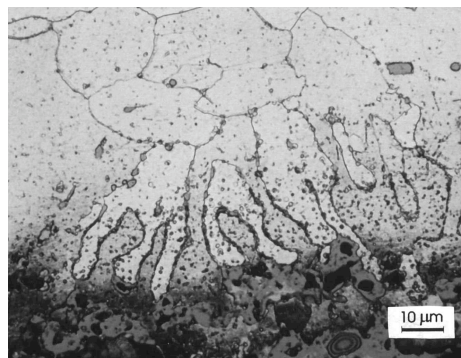
Evidence of grain boundary attack by sulfidation is clearly visible. A gradient in sulfur concentration inward from the surface is shown in Figure 4. The internal sulfides appeared to interact with the penetration of this liquid “slag.”

FIG. 4. Hot Corrosion in WTC 1 or 2 steel.
