AVERHAM, ST MICHAEL, NOTTINGHAMSHIRE: A NEWLY IDENTIFIED PRE-CONQUEST CHURCH

Christopher J Brooke, FSA

and Peter F Ryder, FSA

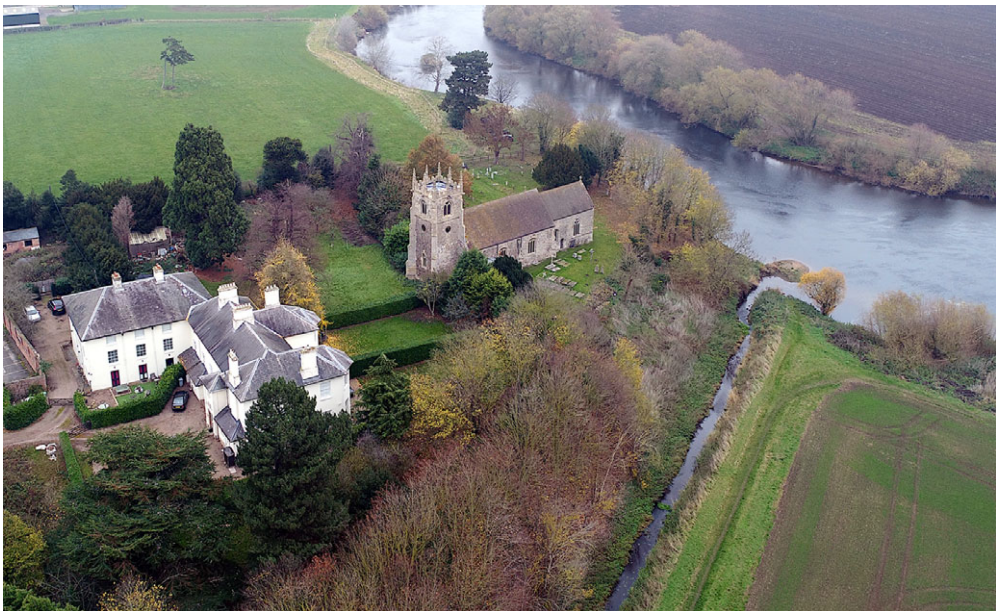
Fig 2. Aerial photograph of Averham St Michael from the south-west showing its isolated position on the west bank of the River Trent. *Photograph*: Richard Carlton.

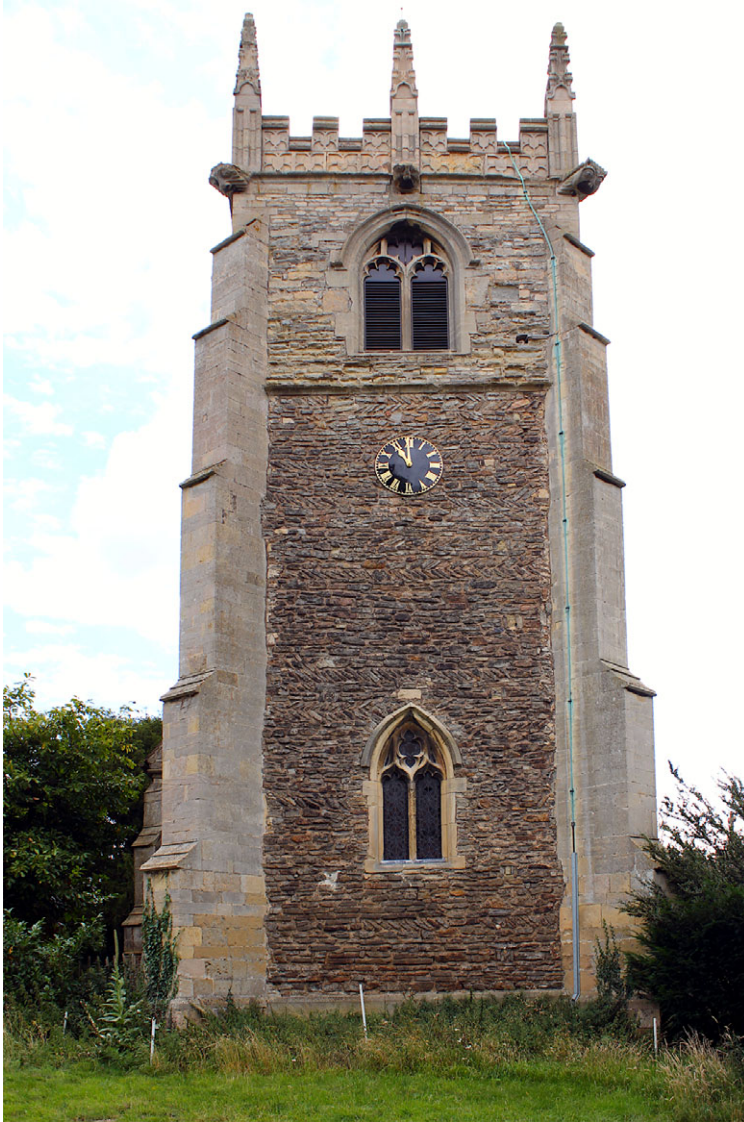
Fig 3. The west elevation of the tower showing the inserted lower window, counter-pitched rubble fabric and later medieval belfry and parapet. *Photograph:* authors.

The west tower (fig 3) rises in one tall, unbroken stage to a casement-moulded string below the belfry; up to this level the walls are of coursed roughly-square stone with much interspersed counter-pitched coursing, and obvious putlog holes. In the west wall are three pairs of putlogs, with one towards each end of the wall, up to the level of the head of the west window, and three more above near the south end of the wall. This early fabric, comprising

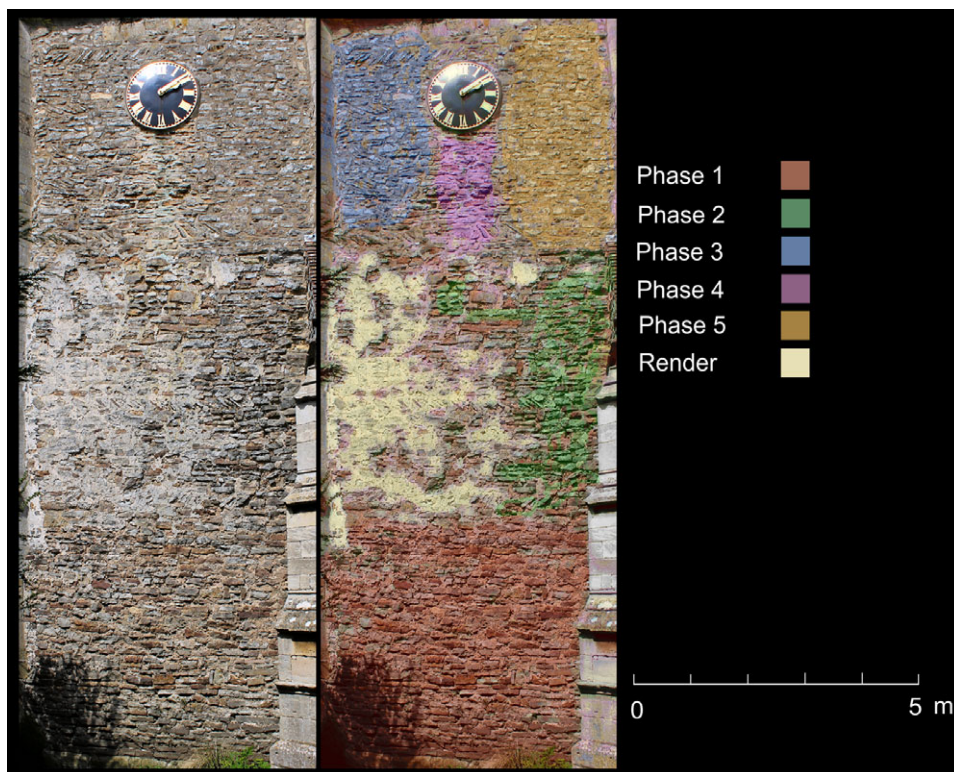
Fig 4. The south elevation of the tower with (right) Random Forest predication showing the different forms of building construction. *Photograph: authors.*

In order to study and highlight the phase differences of the south elevation, an image analysis technique, Random Forest (RF) classification, has been utilised on a rectified, visible light image. RF is a machine learning algorithm often used in remote sensing analysis and is widely regarded as a reliable predictor of specific features, based on a nonparametric method for modelling the continuous and discrete data of decision tree methods.¹⁴ Pixels in the imagery are ‘trained’ using visually discrete zones in the fabric and the algorithm then calculates areas of similarity. Training in this case, using pixel classification for intensity, edge and texture, with the sigma of the Gaussian set between 0.3 and 15.0, has been rigorously controlled to those areas that have visually discrete structural properties in order to avoid over classification or incorrect group assignment.¹⁵ Fig 4 shows a

photograph of the south elevation alongside the RF classification. The five ‘phases’ illustrated are not necessarily in period order, although clearly Phase 1 precedes all other phases but interestingly appears to lie below the rendered area and among Phase 2; this implies that Phase 2 may have been a repair or partial rebuilding.

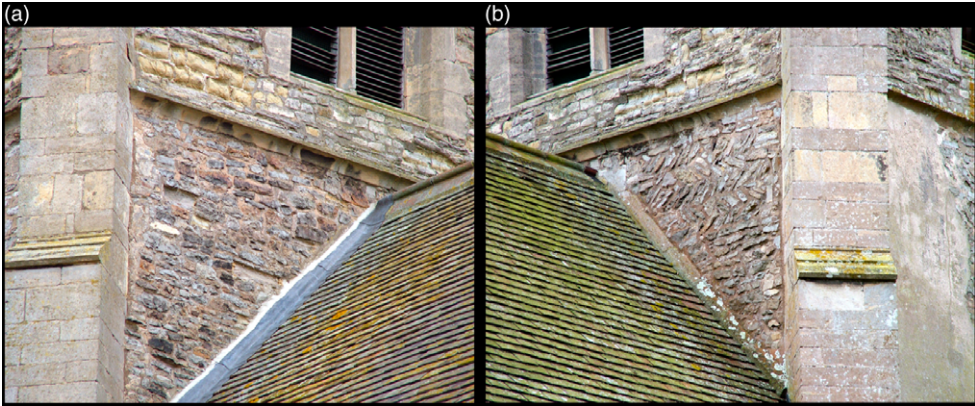
Fig 5. The east elevation of the tower below the belfry stage, (a) on the south side showing coursed rubble construction with no counter-pitching; (b) on the north side showing counter-pitched rubble consistent with the exposed areas of the north elevation and with internal construction. *Photograph*: authors.

On the east, above the nave roof, there is a clear contrast between the early fabric, with counter-pitched courses north of the nave ridge, and rebuilt walling without counter-pitching on the south (fig 5). On this side, the earlier crenellated parapet, at the level of the springing of the heads of the present belfry openings, is very clear.

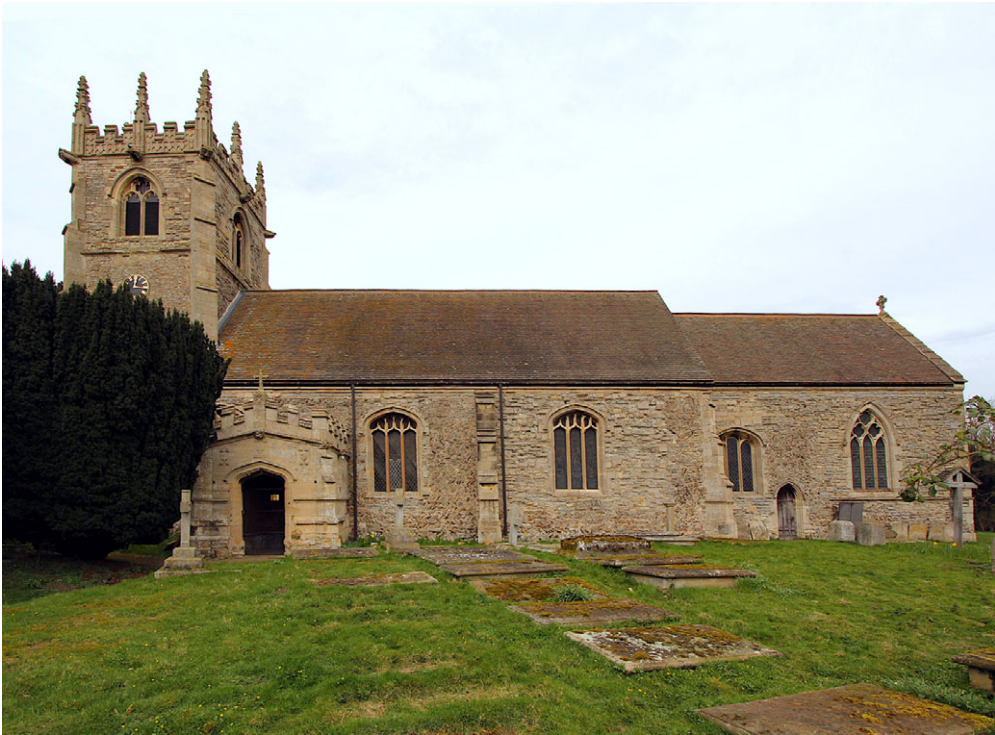
Fig 6. The church from the south showing the varied forms of rubble construction, inserted windows and the early sixteenth-century porch. *Photograph:* authors.

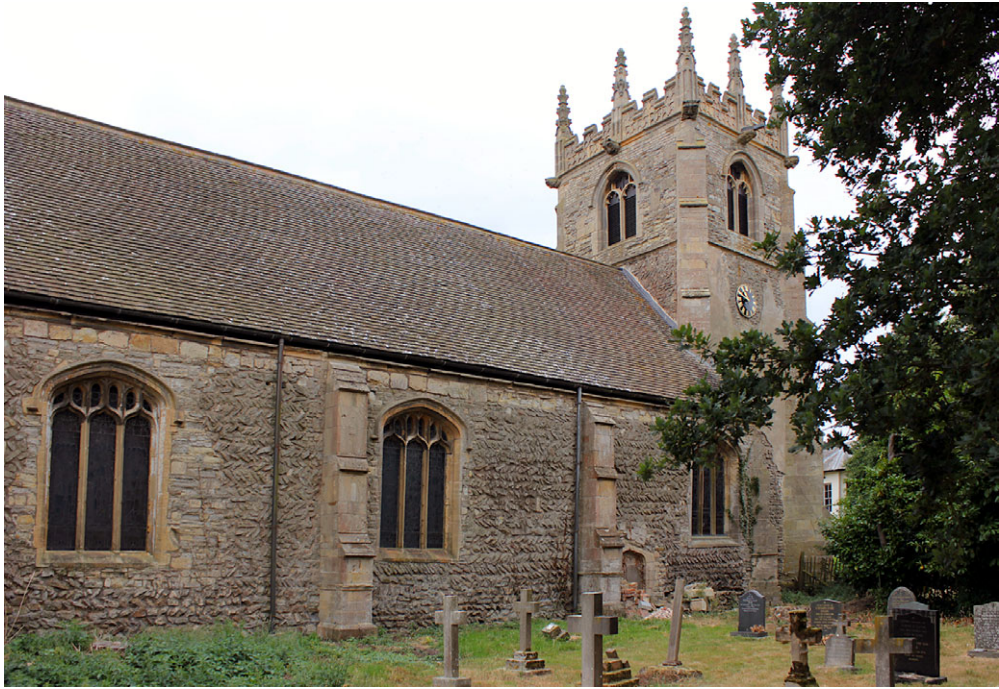
Fig 7. The church from the north-east illustrating the extensive counter-pitched rubble construction of the side walls and the small, blocked Tudor doorway in the western bay. *Photograph*: authors.

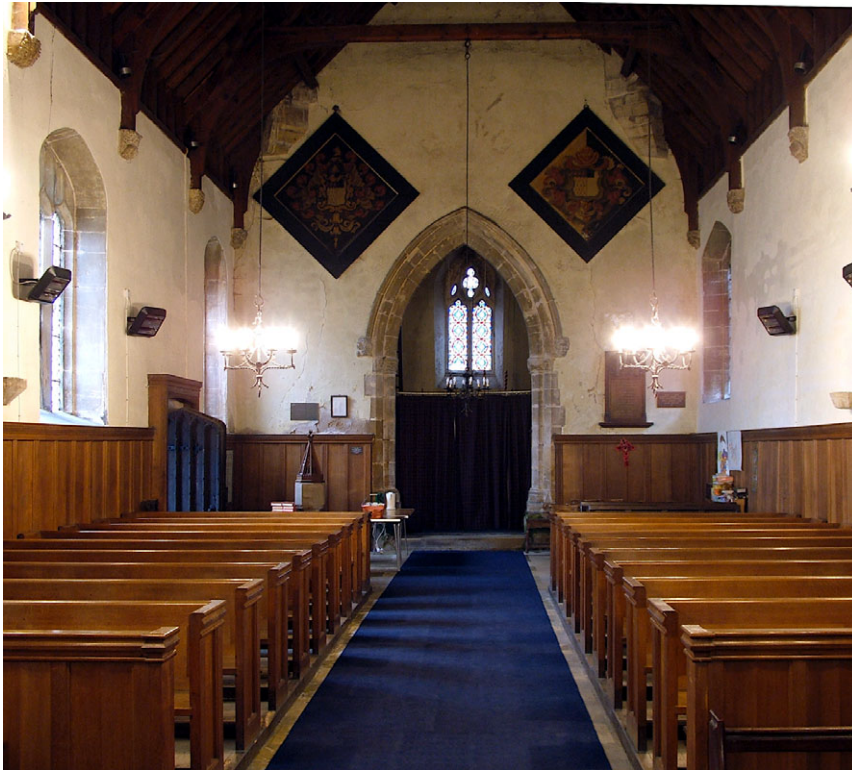
Fig 8. The interior of the church to the west showing the tower arch and west wall.
Photograph: authors.

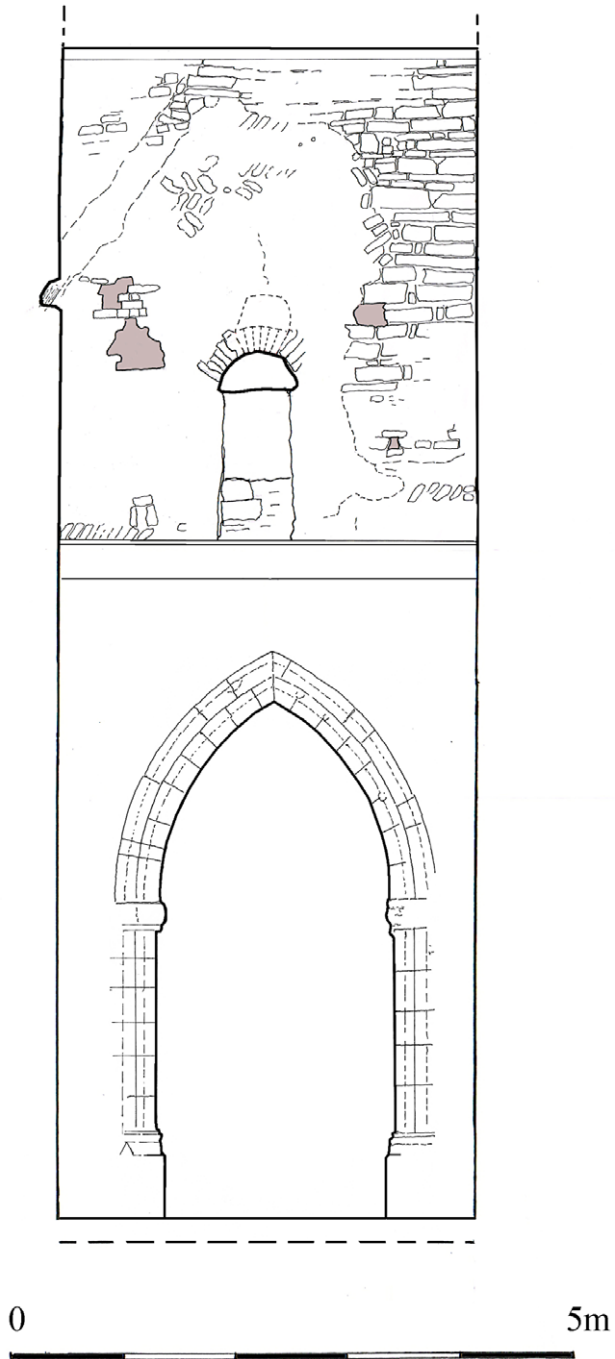
Fig 9. Elevation drawing from the west showing the ground- and first-floor chambers of the tower. *Drawing: authors.*

In the first-floor chamber, 6.1m above present ground floor level (fig 9), set slightly north of centre in the east wall is a blocked opening 0.60m wide and *c* 1.60m high (the base is partially obscured by the modern floor); it has a roughly-arched head with rubble voussoirs, but the centre of the arch has gone (fig 10). A blocking of loose brick was removed from the upper part of the arch in July 2018 in order to effect a safe repair and this revealed early render on the soffit of the arch matching that on the exposed interior east wall; the render is slightly orange in colour. In February 2020 more brick and rubble was removed to effect further repairs and to examine the eastern arch on the nave side of the wall (fig 11). Only 0.29m of the uppermost part of the east face of the doorway was exposed as below this sits a large, flat stone forming a blocking to the nave side of the opening, and remote sensing has revealed medieval wall painting below the limewash covering to this stone extending well to each side and below; however, there was no evidence of painting at the height of the door head. The east face of the arch comprises similar rubble stone voussoirs to the west face, but the presence of some brick indicates later attempts at repair. The brick is all hand-made and probably pre-dates the nineteenth century.

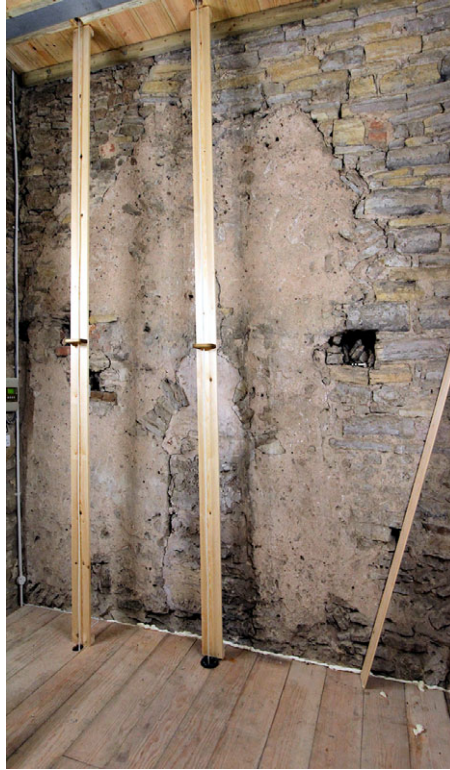
Fig 10. The first-floor chamber of the west tower looking towards the east wall. The blocked, rubble-headed opening is visible in the centre surrounded by light orange mortar. Above, the former pitched roofline is clearly visible, partially interrupted by later alterations. *Photograph:* authors.

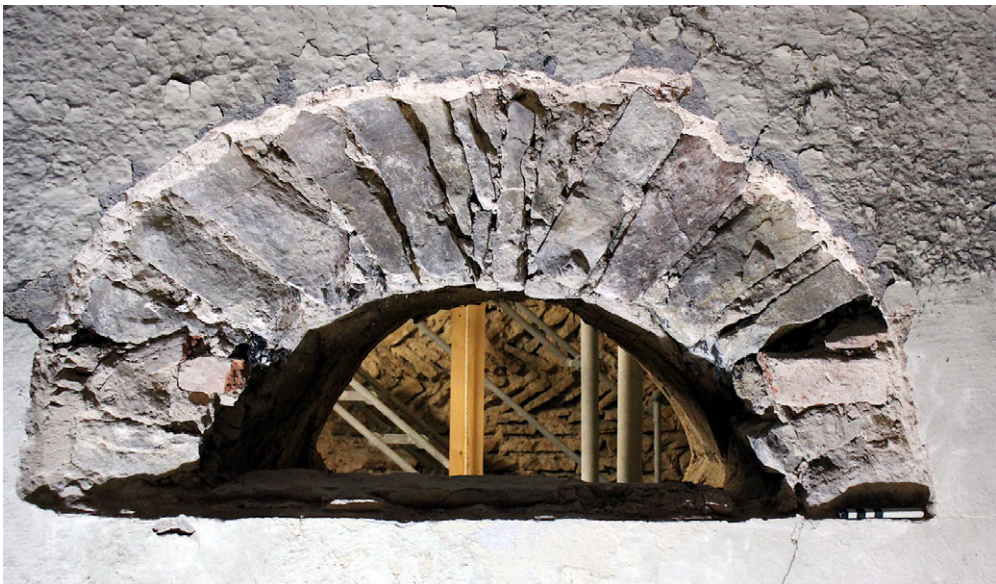
Fig 11. The east face of the blocked, rubble-headed opening. *Photograph:* authors.

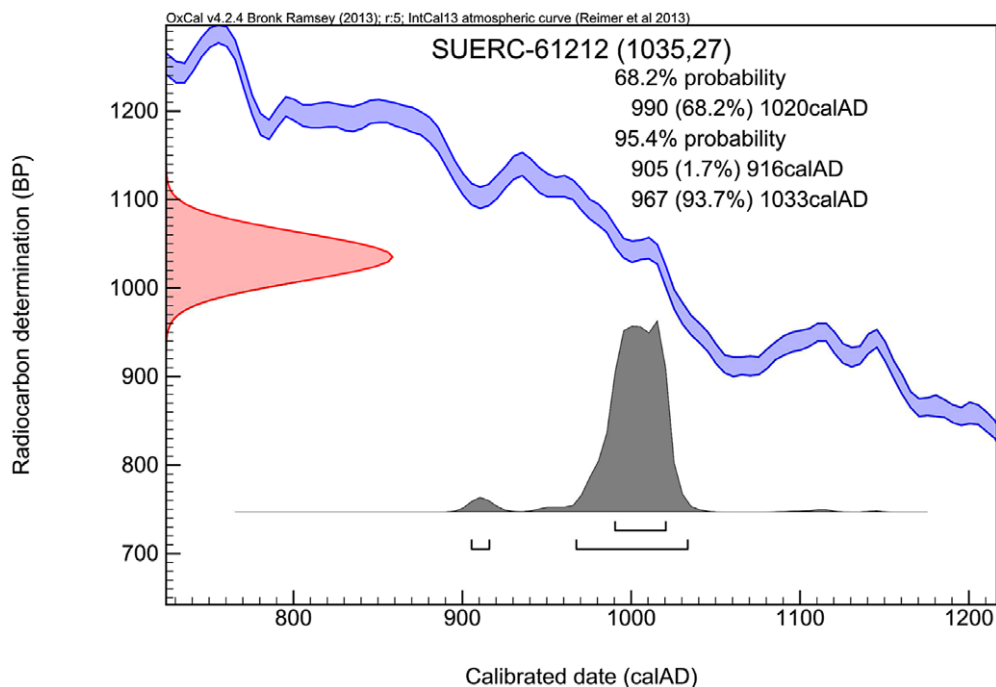
Fig 13. Radiocarbon calibration plot of the rafter sample from the east wall of the first-floor tower chamber. *Drawing: SUERC.*

A small cavity in the extreme north of the east wall exposes part of an *in situ* rafter relating to this roof, now sealed by later masonry above. The oak timber remnant lies precisely on the angle of the former pitched roofline, leaving no doubt that it was a rafter sitting on the top of the north slope of a gable wall. A small core was removed from the timber for dendrochronological dating but proved to have an insufficient number of rings. The core was then sent for radiocarbon dating, which has yielded a corrected radiocarbon date of cal AD 1000±33 years at 93.7 per cent probability.¹⁸ The ¹⁴C date and calibration curve are presented in fig 13; the date is calibrated in OxCal 4.2.4 using the IntCal13 atmospheric curve, and error is expressed at the one sigma level of confidence. The fabric above the roofline to the north is of greyer mudstone. The significance of these features is discussed in the Structural Interpretation section below.

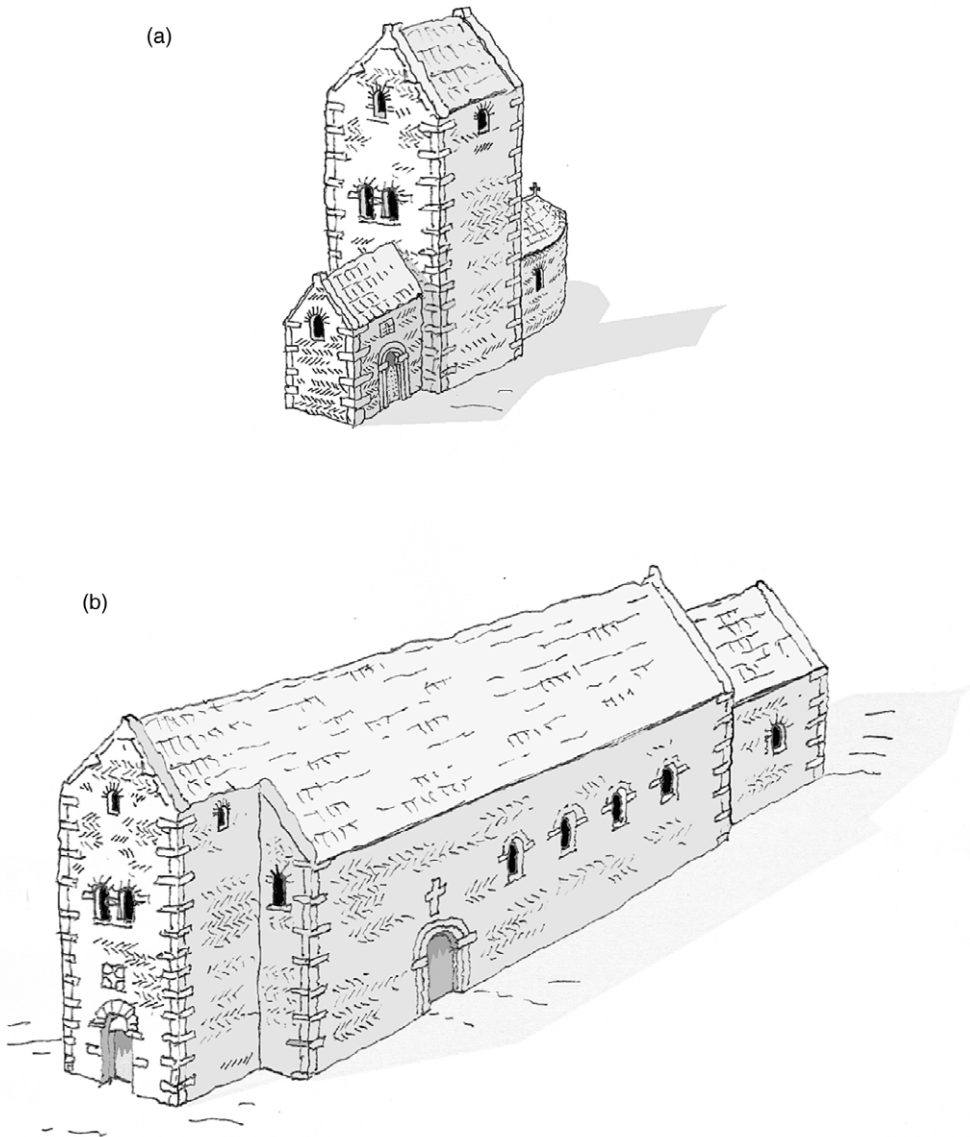
Fig 15. Conjectural reconstruction drawings of Phase I: (a) as a central tower-nave with small chancel and western chamber; (b) with a two-storey western porch, similar to the present and small chancel. Note: the chancels could be either square or apsidal, no evidence survives to confirm. *Drawing: authors.*

The nature of the western structure at Averham is unclear (fig 15). The occurrence of two-storied western church porches in Anglo-Saxon architecture in the UK is rare. Those at Bardsey, Bedford St Peter, Brixworth, Deerhurst St Mary and Monkwearmouth are the best studied and cited examples,²⁴ although the western structure at Brixworth is now thought to be more complex than a simple two-storey porch and is unlikely to be analogous to Averham.²⁵
