# Breaching of an ice dam at Qorlortossup tasia, south Greenland

**ABSTRACT.** In July 2003 an ice-dammed lake was suddenly drained in an outburst flood at Qorlortorsup tasia in south Greenland, the site of a projected hydropower station. The lake developed during the first decades of the 20th century as a result of the recession of the ice cap in this area. It used to drain over a shallow rock spillway towards Sermeq kangigdleq, the adjacent outlet glacier to the north. In order to assess the hazard potential and the additional water contribution from the enlarged catchment, the glacial lake and its surroundings were investigated. Based on the analysis of available historical data, field investigations and model results, the history of lake generation and the sudden outbreak were reconstructed. With the lake formation the ice dam lost its connection to the ice cap. The flood was initiated after the ice surface became low enough for the lake water to overflow the glacier towards Qorlortorsup tasia basin, creating a gully through the glacier which drained approximately  $55 \times 10^6 \text{ m}^3$  of water over a period of 8–10 days. Thanks to the stability of the dam and the dow

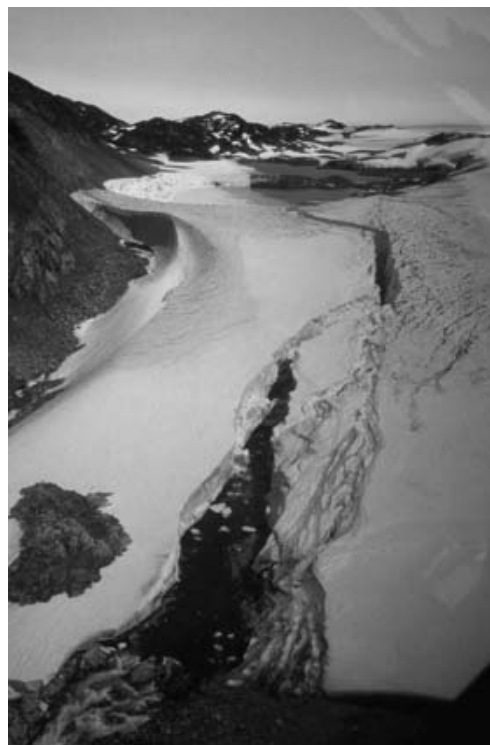
**Fig. 3.** Photograph of the drainage channel cut through the glacier, with the drained lake in the background. The partition into two lakes at different levels is apparent.

At the time of the survey, the outflow from the glacial lake into Qorlortossup tasia basin was reduced to about the discharge corresponding to the inflow from the upstream glacial basin. The water flowed through a gully in the ice dam which is about 1100 m long, 10–15 m wide and at maximum almost 50 m deep. Surface features of widespread water flow over the entire glacier length clearly indicated that the channel formation started by overtopping the glacial dam (Fig. 3).

The computation was started from the following initial condition: the lake level was equal to the elevation of the ice dam,  $z_i = z_c = 40 \text{ m}$  relative to the outlet of the channel. The channel was 1100 m long and its slope was 0.012. From photographs of the channel after termination of the flood (Fig. 3), we determined  $B = 10 \text{ m}$ . We selected  $k = 30 \text{ m}^{1/3} \text{ s}^{-1}$  as a typical value for a mountain stream (e.g. Maidment, 1993). The hypsography of the lake was determined from a digital elevation model that was constructed from air photographs and the ground-based survey after the lake was emptied. Discharge input to the lake was roughly estimated  $Q_i = 1 \text{ m}^3 \text{ s}^{-1}$ .

Observed trimlines in the area (e.g. Fig. 3, left mountain slope) show that during the last maximum ice extent, probably towards the end of the 19th century, the entire lake basin was filled with a glacier, which was then up to 100 m above the modern glacier surface. This glacier reached into the Qorlortossup tasia basin, as well as into the adjacent Sermeq kangigdleq valley. During the general retreat of ice masses in south Greenland since the beginning of the 20th century (Weidick, 1959), ice flow through the Qorlortorsuaq tributary ceased and the ice surface in the recent lake area lowered. The ice flow over the rock spillway into Sermeq kangigdleq was further reduced and the lake started to form, most likely during the 1920s. In 1942, the lake had reached about 60% of its final maximum size. After the ice dam lost connection with the main ice cap, it started to shrink since

Most likely, the water started to overtop the ice dam towards Qorlortossup tasia during the last days of June 2003. This happened first on an approximately 100 m stretch of the glacier (Fig. 3). The water flow subsequently concentrated in a few erosion channels, which started to merge into one channel at the downstream end of the ice dam. This concentration of water flow eventually reached the lake shore, and further erosion/melting of the channel accelerated the process of channel enlargement. The reason why the ice dam did not become afloat is not entirely clear. Most probably the ice dam is frozen to the ground. Annual mean temperatures are only available for Qaqortoq (0.6°C (Hanna and Cappelen, 2003)), which indicates an annual mean temperature of approximately -5°C at the lake. Because the ice dam is not dynamically active, such a mean surface temperature would be low enough for freezing conditions at the ice base.
