IMPACTS OF GLACIER-RELATED LANDSLIDES ON THE SETTLEMENT AT HOPAR, KARAKORAM HIMALAYA

ABSTRACT

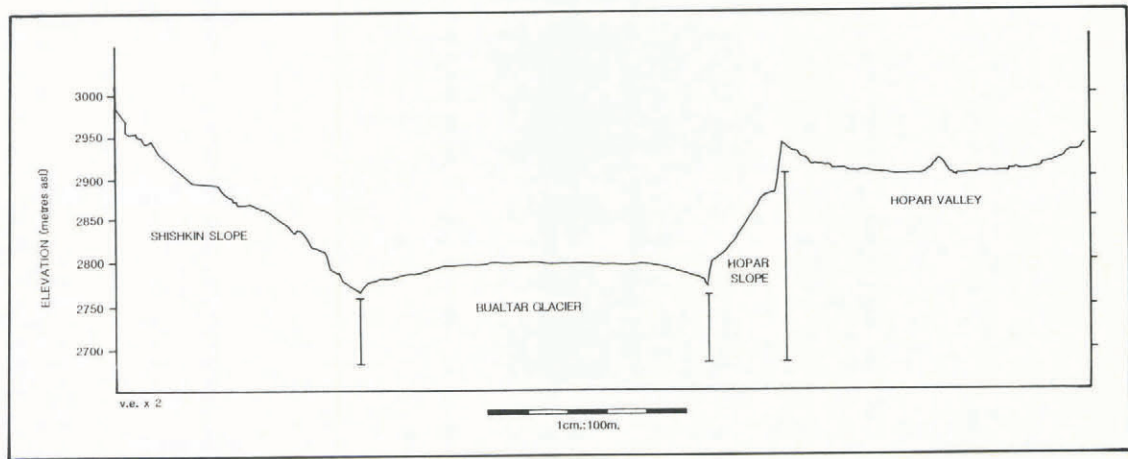
Fig. 2. Cross-section of surveyed areas of Hopar, Shishkin, and Bualtar Glacier, 1986.

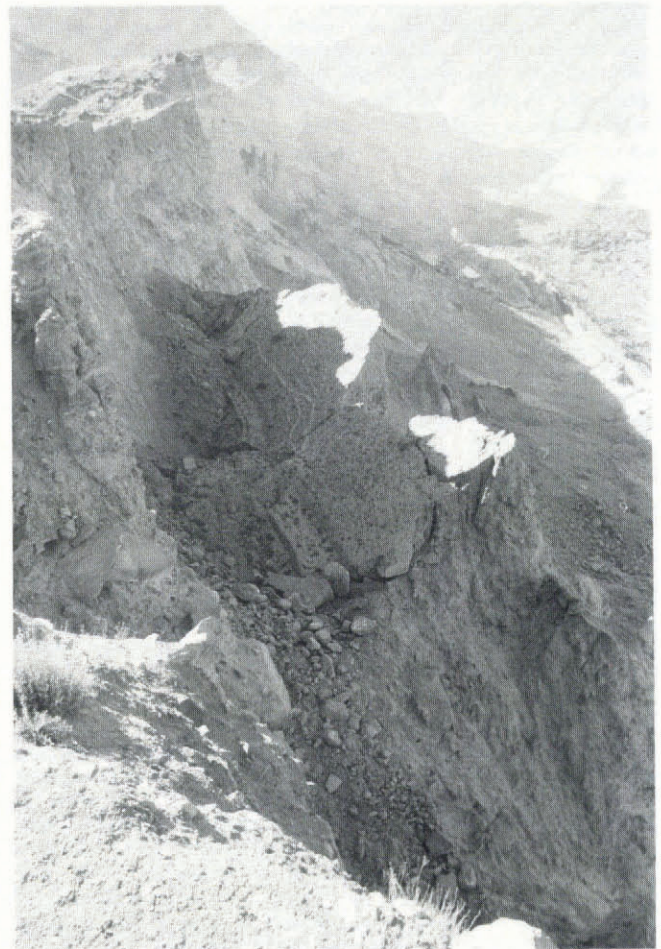
Fig. 3. Slump blocks on Hopar slope. Block in foreground, detached about 8 years ago, now sits 35 m down the face and has carried away the old jeep road. View from moraine crest down-glacier, showing Bualtar Glacier in upper right corner.

extend in both width and depth as large blocks slump and descend down the slip face (Fig. 3). Down-slope there is a vertical transition in form of the relatively intact blocks found at the top through various stages of break-up. At lower levels, entire areas of the steep face appear as series of superimposed slumps coalescing near the glacier margin. The distal toes of the deposits are continually cleared by rapid ice flow as debris is both incorporated subglacially and also transported in marginal melt-water streams. Movement of blocks down the face appears to be slow and intermittent, as no appreciable movement of developing

slump blocks or degraded slump masses was detected during two consecutive years of observation. Local residents suggest that one particular slump block which now sits 35 m down the cliff face became detached in 1979 or 1980, indicating an average movement rate of about 4.5 m a^{-1} . From recorded measurements and the statements of local inhabitants, it is suggested that movement is periodic and is related to a number of factors including fluctuating thermal conditions on the face and the rapid infusion of water down the cliff face during spring snow melt. The presence of at least two small springs surfacing about halfway down the exposed cliff face also suggests that the action of ground water reduces the shear strength of parts of the slope. Further, basal erosion through rapid flow at the ice-slope interface and the thinning of Bualtar Glacier act to remove lateral support and increase shear stress at the base of the slope.

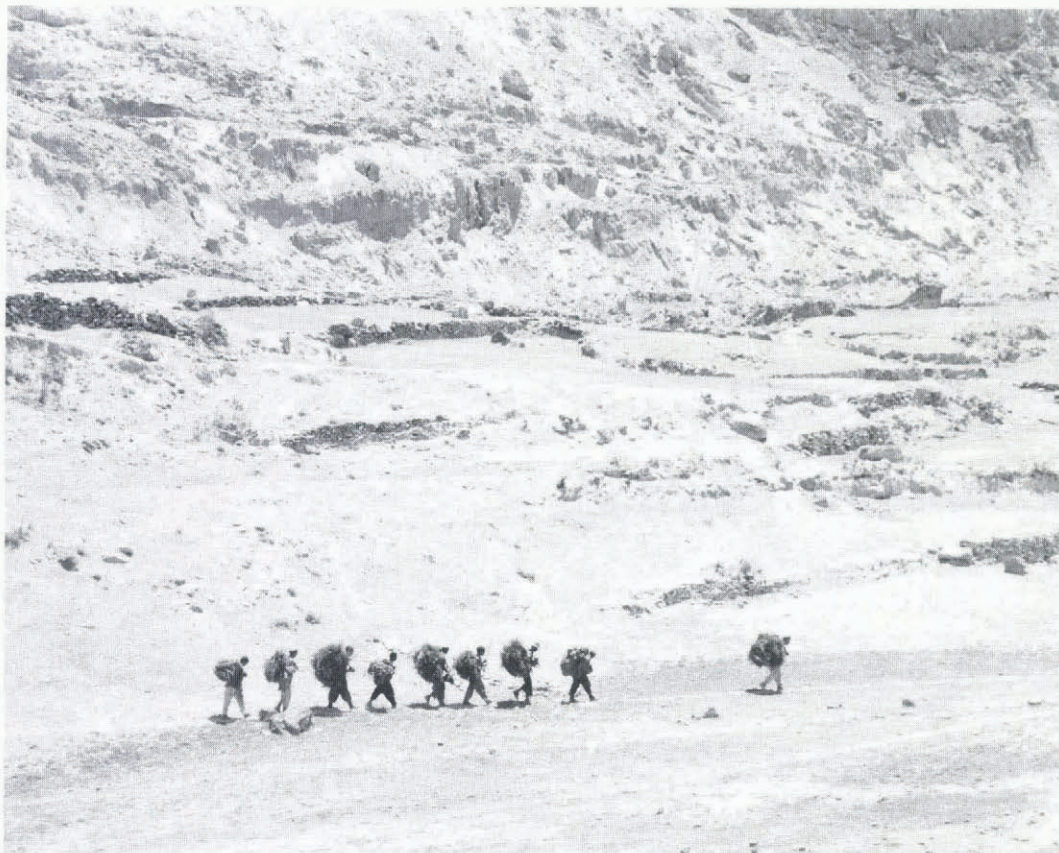
Fig. 4. Hopar villagers carrying firewood across fields of Shishkin. Note abandoned terraces, and slide scarps in upper half of photograph.

Considering the processes discussed above, the extent of physical and economic damage in Hopar is evident. As average annual precipitation is less than 130 mm at elevations below 3500 m a.s.l., irrigation water is the mainstay of life. Thus, the most severe physical impact is the occasional disruption of water supply and the infrequent complete destruction of irrigation channels. Similar landslides to those described for Hopar led to the abandonment of the settlement at Shishkin, a large summer village at the right side of Bualtar Glacier (Fig. 1) within the last quarter century. According to local informants, Shishkin once consisted of 40–50 dwellings, with terraced fields in which irrigation water supported the cultivation of wheat, barley, potatoes, alfalfa, and apricots. A combination of the rapid thinning of Barpu Glacier (Fig. 1) in the last 20 years to levels below those at which melt water can be delivered by gravity to the fields, and the recurring slumping of the moraines have hindered efforts to reconstruct irrigation channels across the slope, effectively putting an end to farming (Fig. 4). The extent of physical damage in Shishkin is shown in Figure 5.

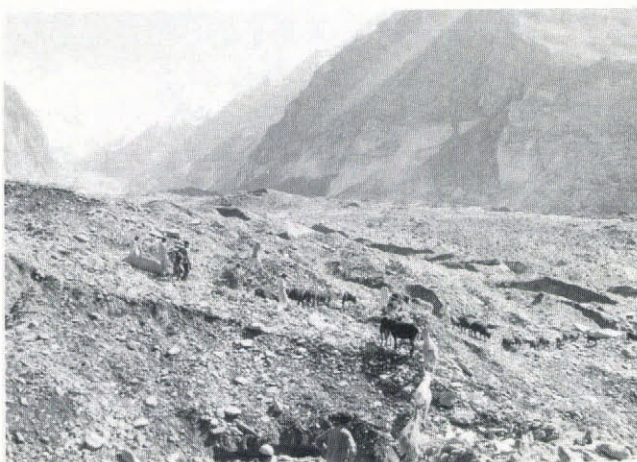
Fig. 6. Animals being herded across Bualtar Glacier to Hopar, from areas of high pasture. Daily fluctuations in ice-surface condition and slope form pose a severe hazard both to humans and to animals.

Another major impact of these landslides is the interruption and destruction of transport routes. Small footpaths which are routed on top of, and descend, the Hopar cliff face, lead across Bualtar Glacier to areas of summer pasture and wood fuel. They are continually altered due to patterns of sliding. In addition, Hopar recently lost large sections of the original jeep road. This alteration of pathways is particularly important in a society in which transhumance forms an important part of the traditional economy. Routes up-glacier and across-glacier have been affected both by slope failure and by glacier behaviour. In 1986, for example, a relatively small landslide damaged the upper part of a path down the Hopar face and significantly increased the hazard to humans and animals using the path. Similarly, it was not unusual to observe the demise of sheep and goats which had slipped into crevasses when ice-surface conditions obstructed the route across Bualtar Glacier (Fig. 6). Rapid ice acceleration during 1987 crevassed the
