A multiscale approach to survey of military and trade architecture in Jordan: the case of Khirbet al-Khalde

This article reports on the archaeological survey of a (military) fort and (trade) caravanserai at Khirbet al-Khalde in southern Jordan, along the eastern Roman frontier. The results reveal the site's resilience and destruction up until the present day and the need for monitoring of threats to its preservation.

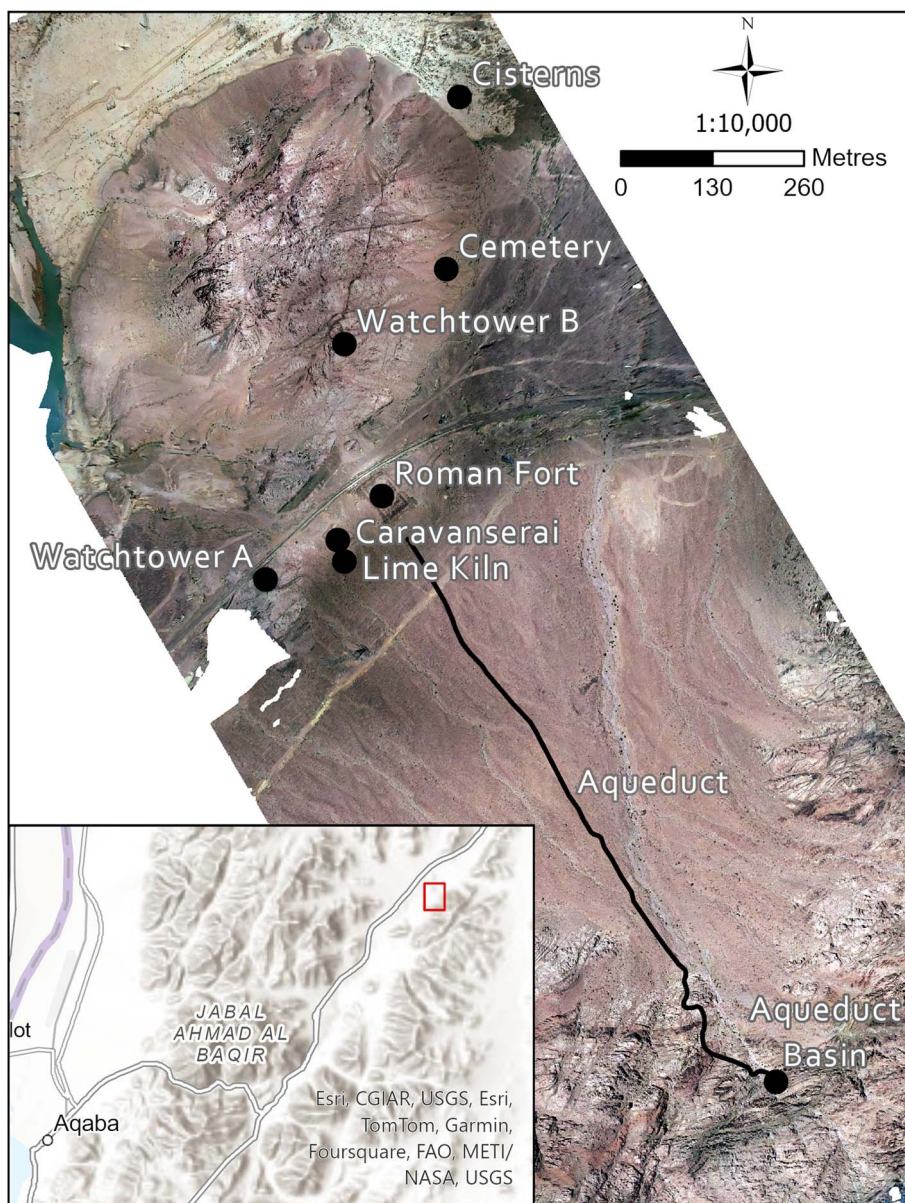
The site at Khirbet al-Khalde, 26km north-east of Aqaba in the Wadi al-Yutm, encompasses a fort, a caravanserai, two watchtowers, cisterns, an aqueduct and cemeteries (Figure 2).

Figure 2. Drone imagery of site with important features highlighted (image from the Khirbet al-Khalde Archaeological Project).

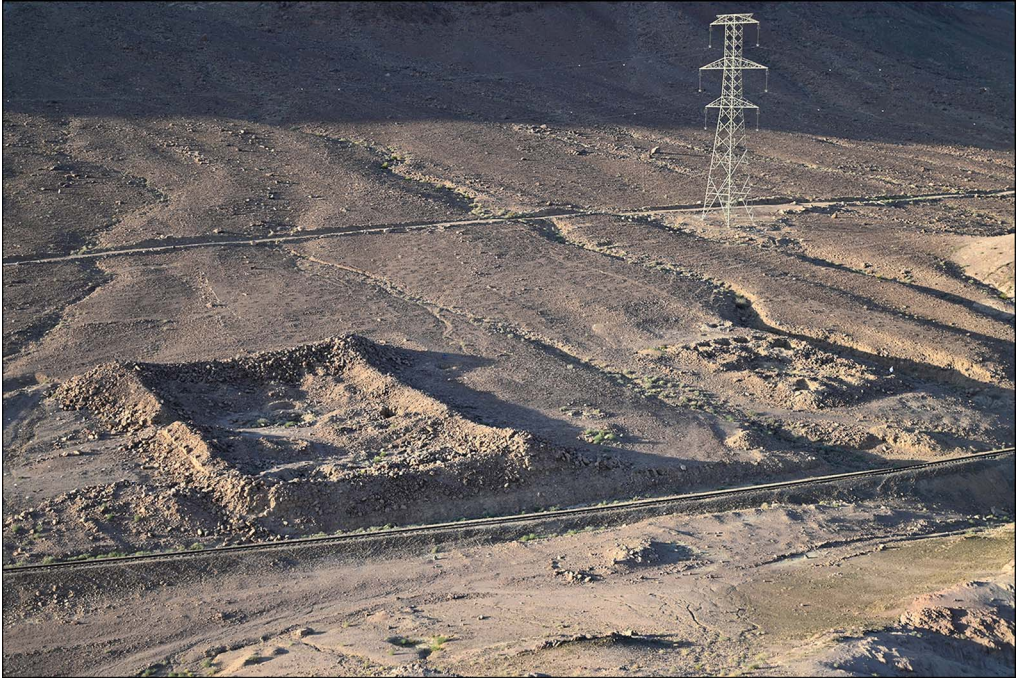
These remains have suffered extensive damage from modern disturbances, including looting and bulldozing (Figures 3 & 4). The area was visited by travellers and archaeologists in the nineteenth and twentieth centuries, and their reports are crucial to understanding the site's general chronology and its function as a military and trade station along this frontier (Kennedy 2002). However, despite the site's significance and earlier work (e.g. De Backer & Scott 2015), the new survey is the first systematic archaeological investigation with focus on site chronology, high-definition mapping, resilience and resource

Figure 3. Overview of main site, facing south (photograph by Khirbet al-Khalde Archaeological Project).

In this project, the site's aqueduct, which connects the fort to a spring approximately 1km to the south-east, was studied to assess chrono-resilience and resource management. In 1939, Stein recorded this aqueduct, but his description lacks detail and presents several misinterpretations (Gregory & Kennedy 1985: 312). In 2023, our survey traced the aqueduct's line and mapped its route with a total station and handheld Garmin GPS. Visible sections of the aqueduct were photographed and described, and loose pipe and mortar samples were collected. In addition, the aqueduct's route was photographed in high resolution by a drone (Figure 3).

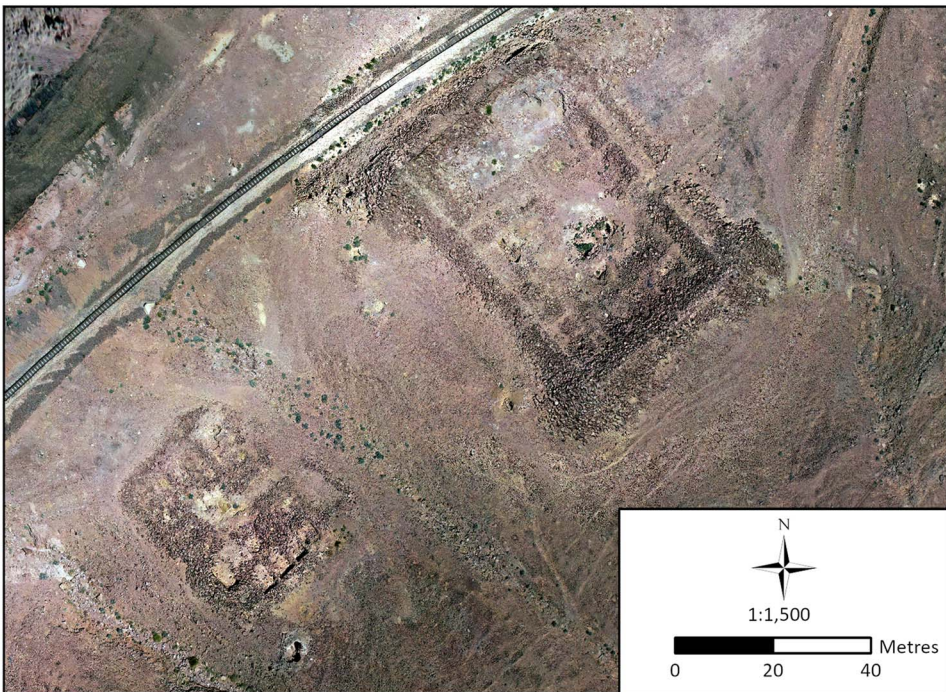
Figure 4. Composite image of Roman fort and presumed caravanserai (figure by Khirbet al-Khalde Archaeological Project).

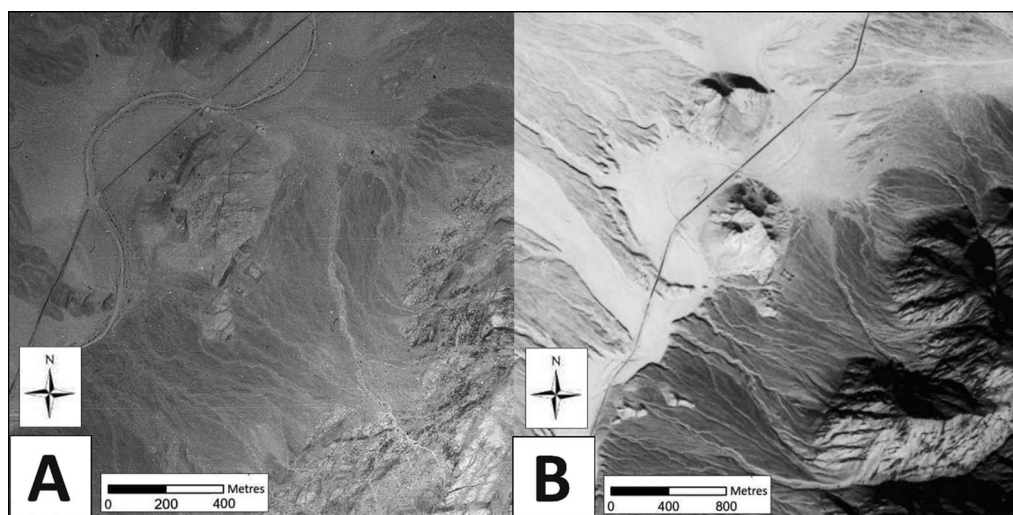
The Hunting Aerial Survey of Jordan in 1953 contains two aerial photographs of the site. Neither of these show any major damage to its remains, although the Desert Highway is clearly visible to the west of the site (Figure 5A). Satellite images from the Corona database taken in 1967 also show no traces of major damage to the site (Figure 5B). With the construction of the railroad, from 1975 onward, access to the site and broader local and regional knowledge of its remains improved, which in turn also facilitated its looting. This access and familiarity no doubt further increased after the later commissioning of the electrical transmission line and its access road, which bisects the site to the south-east of the fort. During the recent survey, approximately 50 looters' pits of varying sizes around the main structures were documented (Figure 6) in addition to a heavily disturbed cemetery to the north-east. It had at least 44 graves, all of which were illicitly dug into at some point after the date of the corona images (Harvey *et al.* *in press*).

Figure 5. A) aerial photograph of Khirbet al-Khalde from 1953 (photograph by Hunting Air Survey, courtesy of Aerial Photographic Archive for Archaeology in the Middle East); B) Corona satellite image (United States Geological Survey (USGS), Earth Resources Observation and Science (EROS) Center Archive).

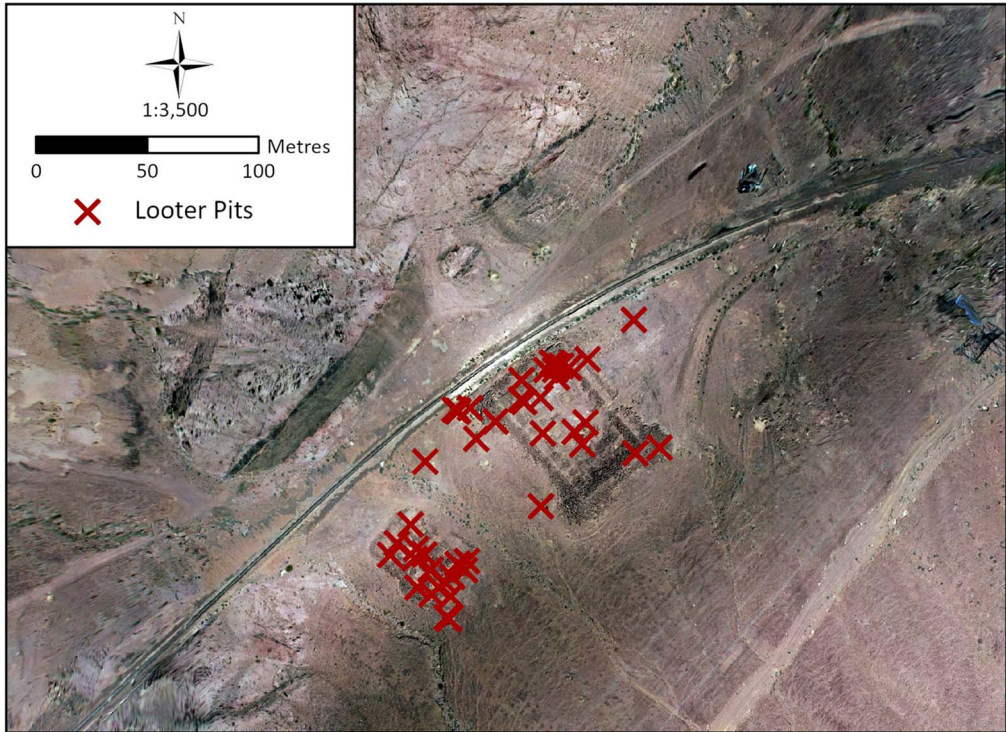
observation, but also assessed that the entire area north-east of the fort had been heavily bulldozed on several occasions. One bulldozing event occurred during the construction of the railroad, which runs alongside the north-west wall of the fort and comes within 10m of its remains. The area in front of the fort carries traces of bulldozing and the find-rich surface shows that archaeological material has been moved around extensively to create a level surface for constructing the railroad. During this process, the tower was probably partly bulldozed.

Figure 6. Drone imagery of main site showing locations of disturbance (image from the Khirbet al-Khalde Archaeological Project).

railroad caused significant damage to the structures through bulldozing and increased access to the site, which also facilitated looting. The existence of numerous looting pits within the small area of 0.8ha underlines an urgent need for archaeological and preservation work. The documentation of modern disturbances has proved crucial to define research plans and goals by identifying areas most at risk and will guide future archaeological research at Khirbet al-Khalde.
