## Corrosion Casting of the Microvasculature in Normal Limbs and Limbs with Venous Ulceration.

M.N. Phillips,\* \*\* A.M. van Rij,\* M. Zhang,\*\* and G.T. Jones\*.

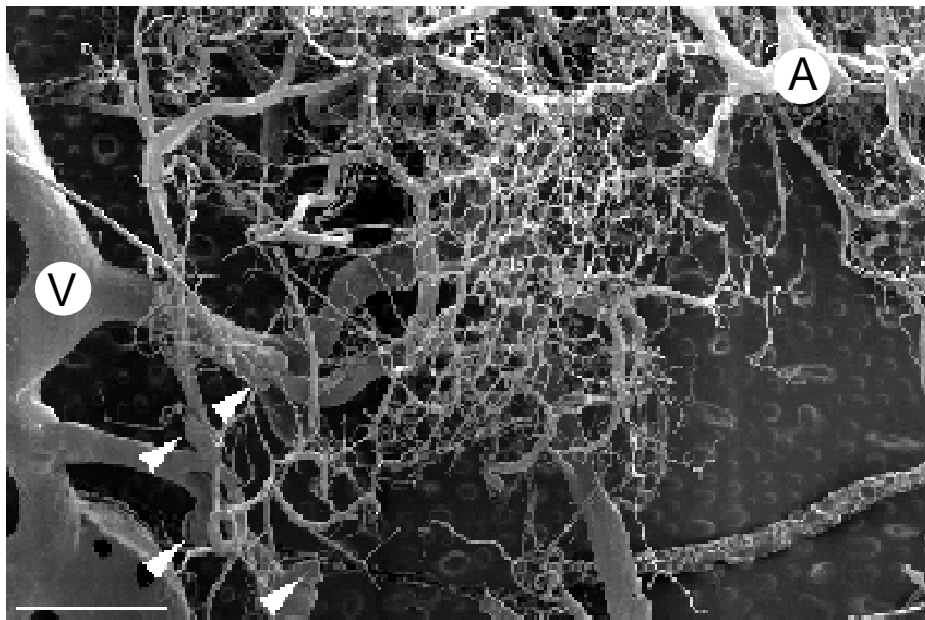
FIG 1. The capillary bed networks associated with an artery (A) and vein (V). Four venous valves (arrowheads) are easily visible. Bar = 2mm.

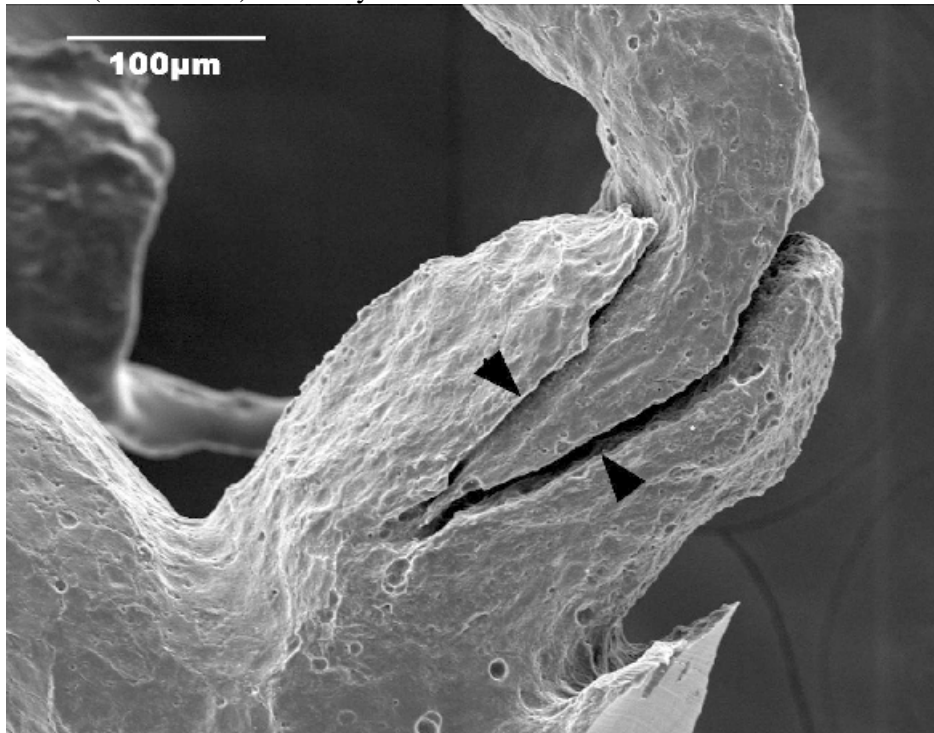
FIG 2. Example of the appearances of bicuspid venous valve identified by SEM of resin corrosion casts. A full venous valve cast, containing both the proximal and distal halves of the valve, joined by a small amount of resin passing between the cusps (arrow heads). Bar = 100µm.

Small venous valves were present in all regions from the normal limbs and limbs with venous ulceration (FIG 2), The valve number, density and size distribution between the normal and diseased limbs were not different. However, the limbs with venous ulceration had a greater density and tortuosity of veins filled with resin compared with normal limbs (153.8 vessels/cm<sup>3</sup> vs. 15.1 vessels/cm<sup>3</sup> respectively). Consequently, the valves/vein-density was lower in the diseased limbs when compared to the normal (0.02 vs. 0.16 respectively). This may reflect microvenous reflux in these diseased limbs.
