## Surface Treatment and Layer Structure in 2H-GaN Grown on the (0001)<sub>Si</sub> surface of 6H-SiC by MBE

### Abstract

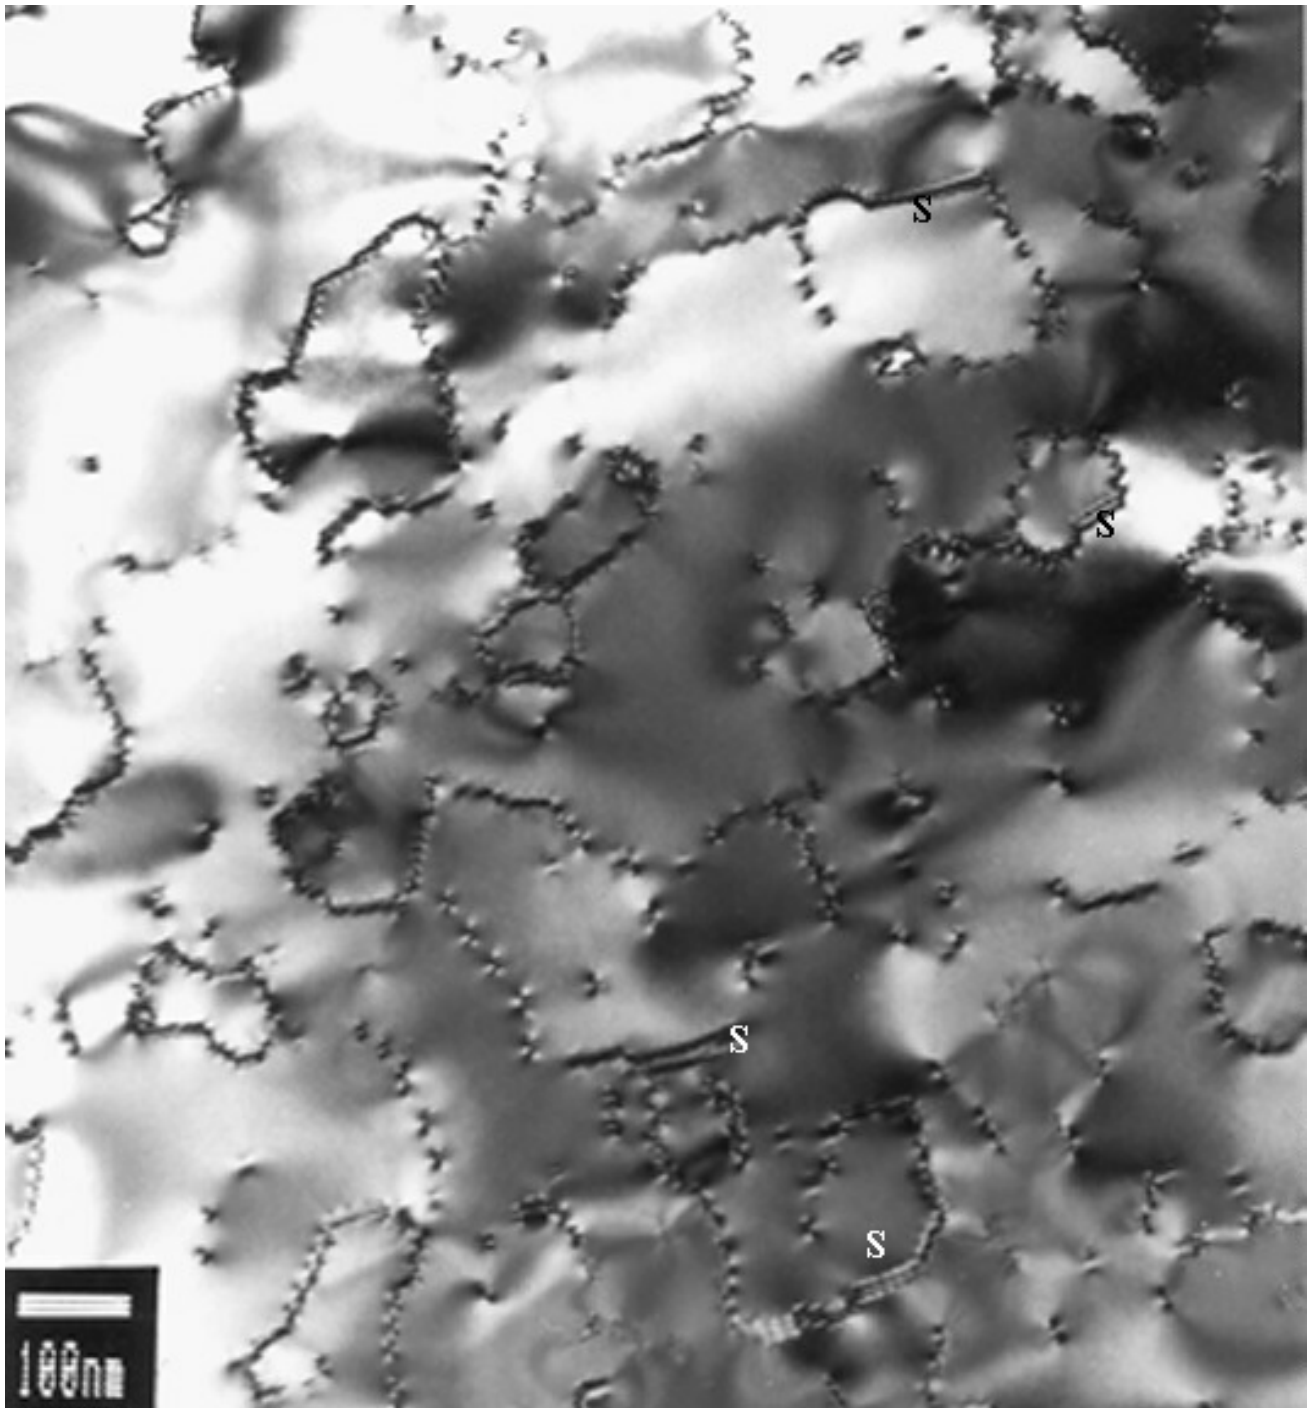
**Figure 1.** Microstructure of a GaN layer grown on 6H-SiC (0001)<sub>Si</sub> surface after chemical cleaning, micrograph taken close to [0001] zone axis, S: the  $\{11\bar{2}0\}$  stacking faults.

When the epitaxy was carried out directly after chemical cleaning the layers always exhibit 3 dimensional growth, the defect densities are very high ( $3 \times 10^{11} \text{ cm}^{-2}$ ). In the worst cases (Figure 1), the prismatic {11 $\bar{2}$  0} stacking faults cross the whole layers which exhibits a pronounced mosaic structure. The stacking faults, which are known to originate from the surface steps [6], accommodate displacements along the c axis between neighbouring domains which are rotated following their relaxation by the formation misfit dislocations

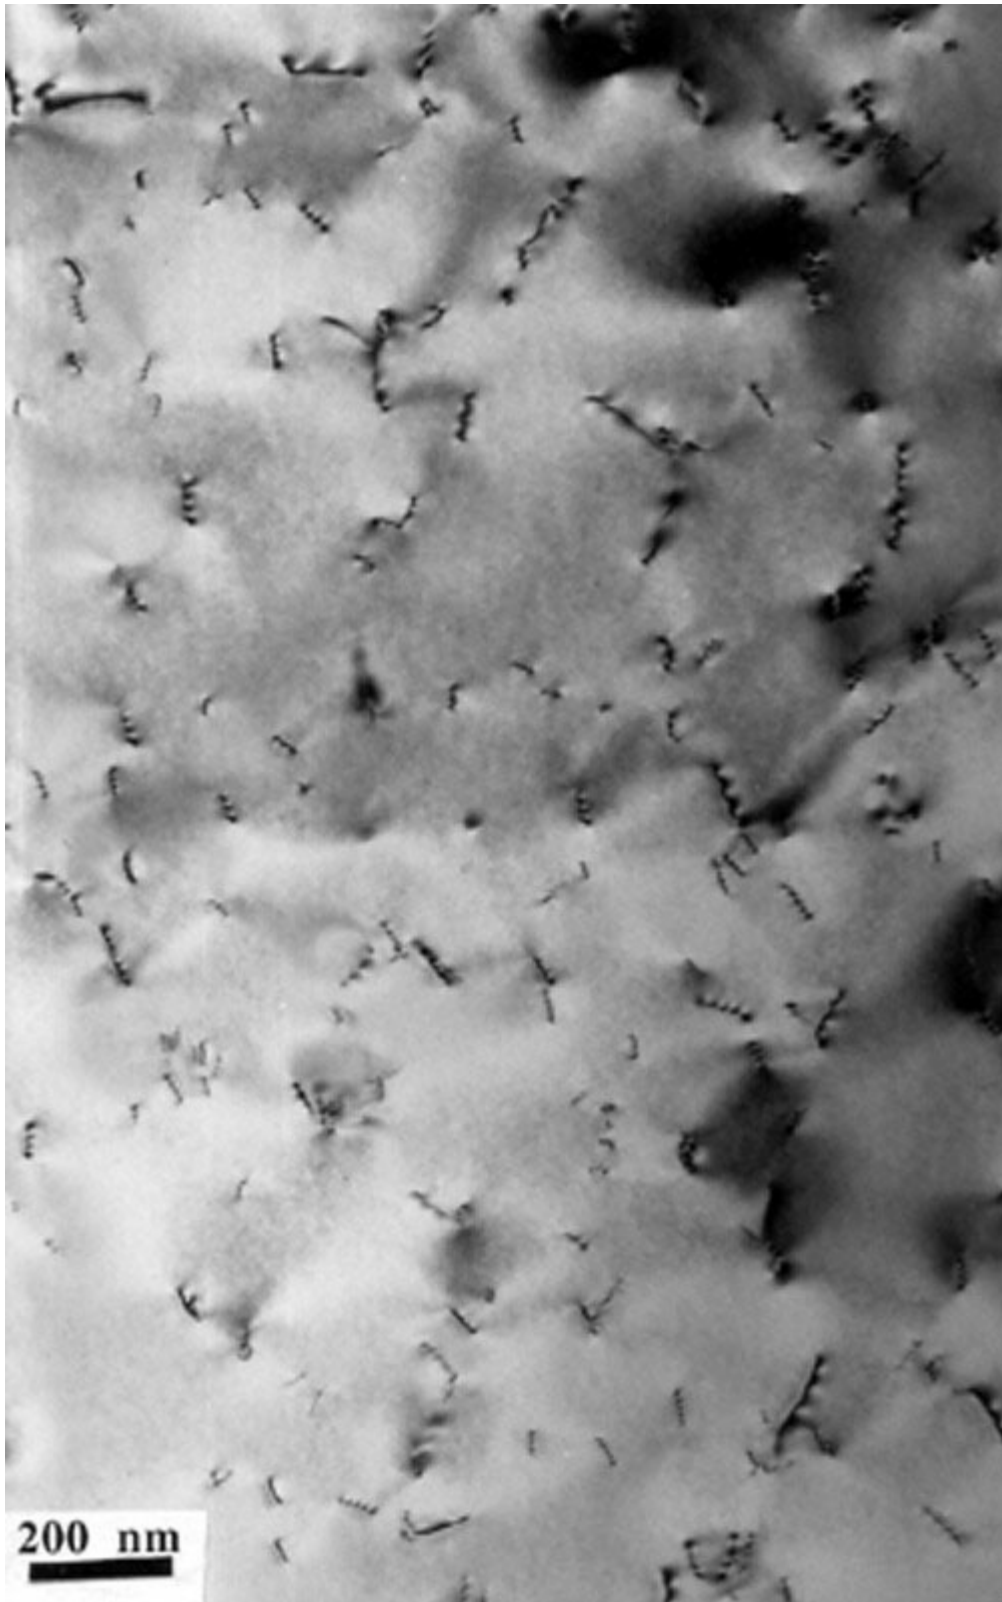
**Figure 2.** Morphology of a GaN layer grown on a hydrogen plasma cleaned SiC substrate, BF image taken at  $g = 00\bar{1}1$ .

When an additional H<sub>2</sub> plasma step is added to the chemical cleaning, the dislocation density can be lowered by another order of magnitude in the  $10^{10} \text{ cm}^{-2}$  range (Figure 2) and it can be noticed that the domains are slightly larger than in the above case. The observed defects are the threading dislocations that are still mostly **a** type. The prismatic stacking faults are now only in the interface area, they may form closed domains or be terminated by partial dislocations [6] [7]. In some cases, {10 $\bar{1}$  0} domains are observed in the interface area (Figure 3). When examined in HREM, these domains contain amorphous material (Figure 4). In planar view, they are clearly limited by {10 $\bar{1}$  0} facets and some of them exhibit an **a** dislocation character [8]. They constitute another factor that seems to be a consequence of the three-dimensional growth mode of the GaN layers on SiC.

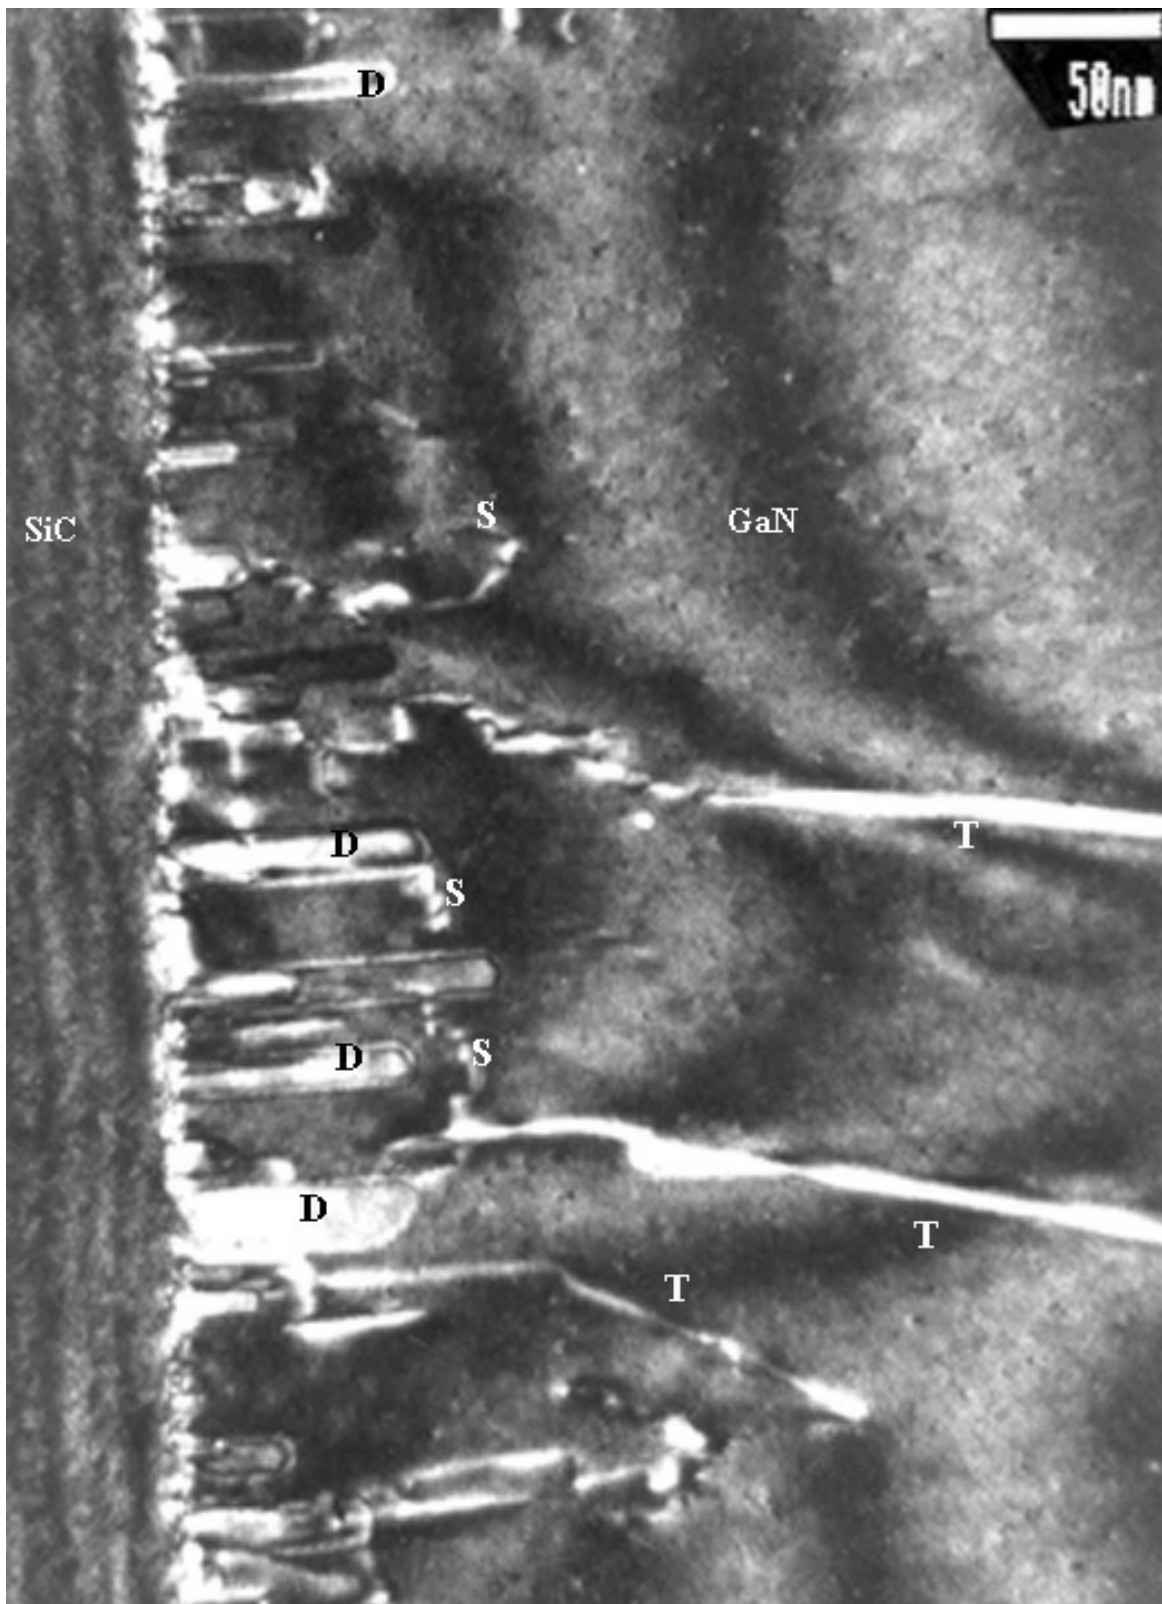
**Figure 3.** Cross section TEM view showing S:  $\{11\bar{2}0\}$  stacking faults and D:  $\{10\bar{1}0\}$  domains, the image is underfocussed in order to enhance the contrast of the domains walls, g: 0002, T: the threading dislocations which have a **c** component.

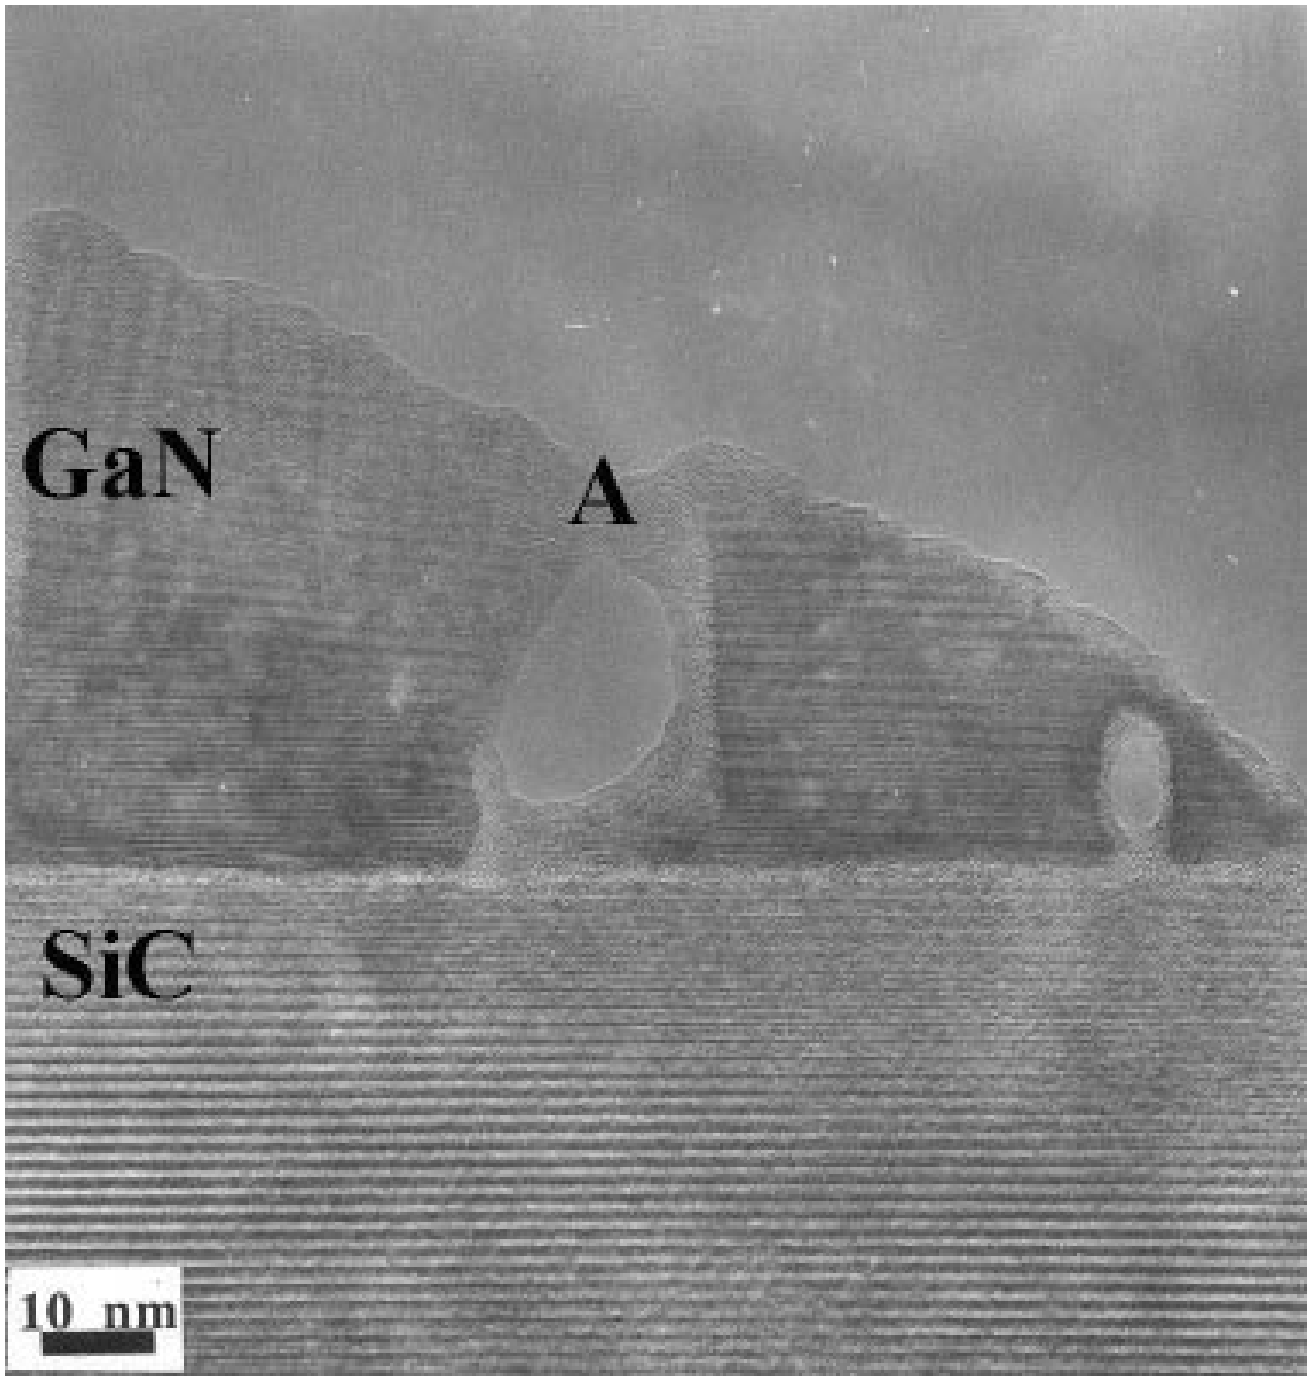
**Figure 4.** The  $\{10\bar{1}0\}$  domains: HRTEM image along the  $[11\bar{2}0]$  zone axis, A: remaining amorphous of the domain.

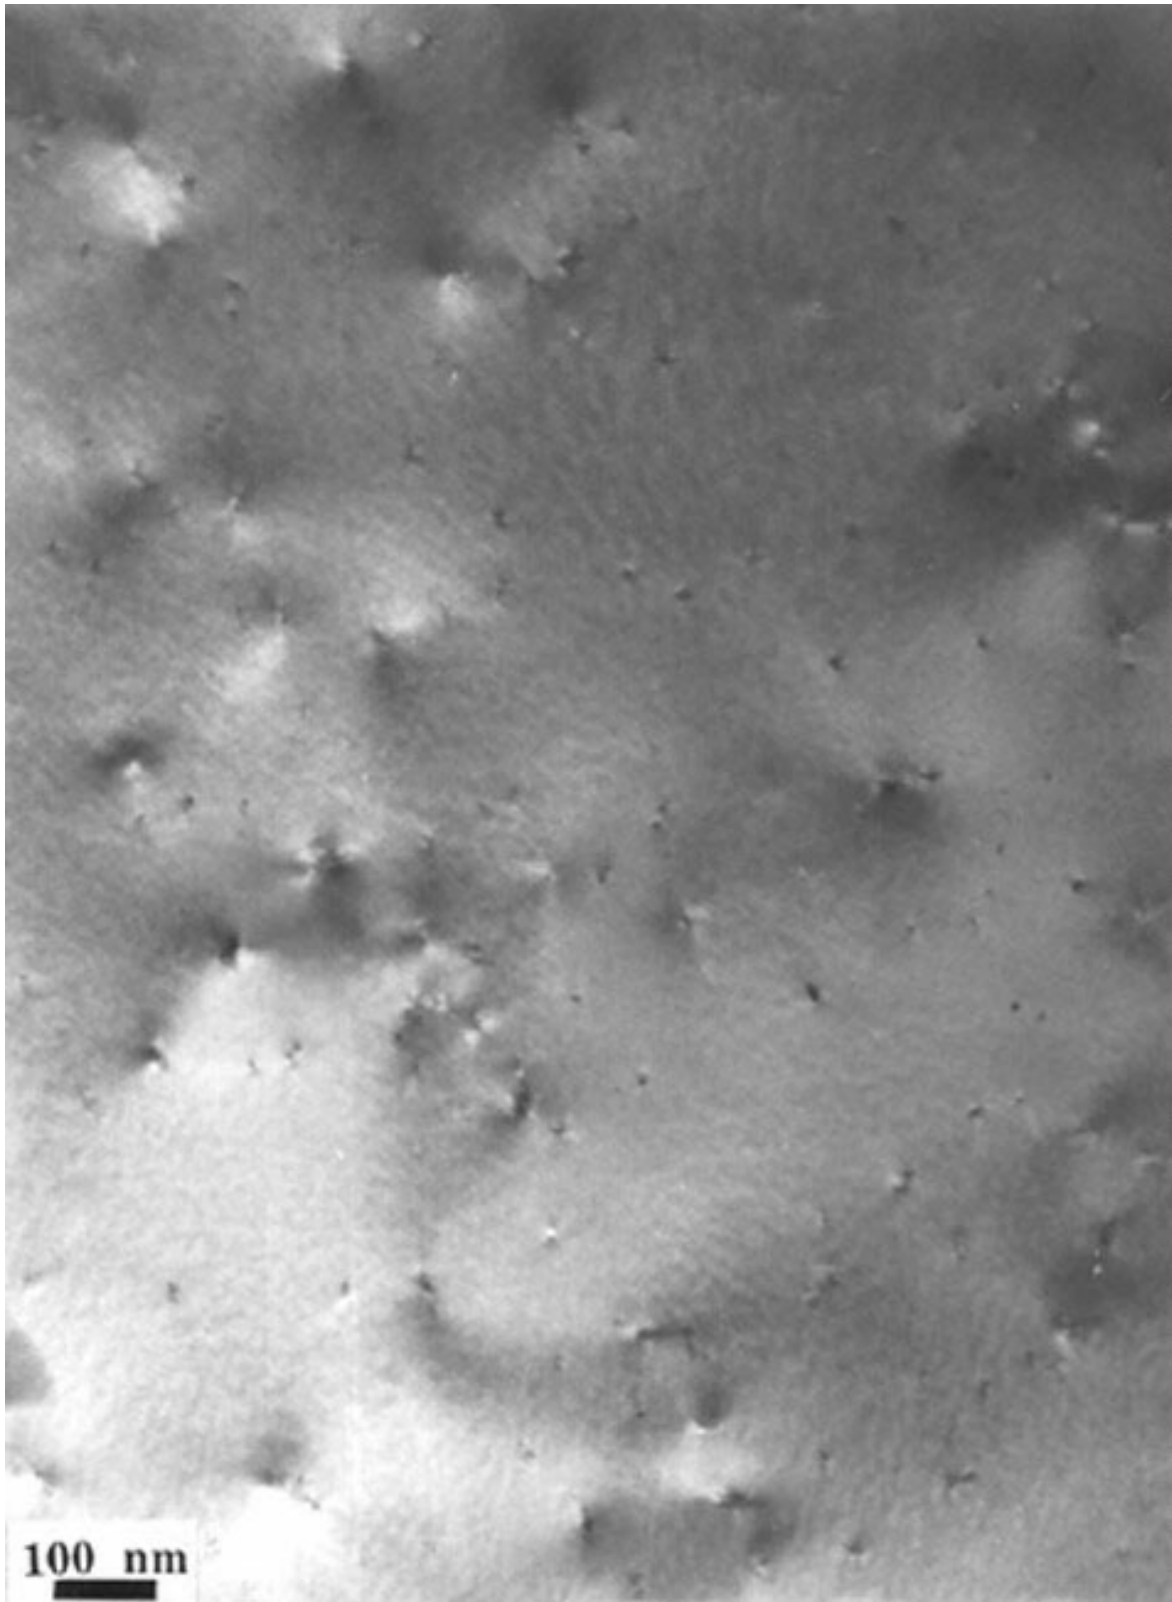
**Figure 5.** Micrograph of GaN layer grown on high temperature SiC substrate: weak beam, dark field image,  $g: 0002$ .

After a 1300°C substrate annealing subsequent to the above treatments, one gains another order of magnitude in the density of dislocations, it drops now to the  $10^8 \text{ cm}^{-2}$  range (Figure 5). As this sample was grown simultaneously with the one shown in figure 2 above, the dislocation density decrease is only due to higher temperature annealing of the substrate. This is a clear indication that the structure of the GaN epitaxial layers on SiC is critically dependent on the surface of the substrate just before epitaxy.

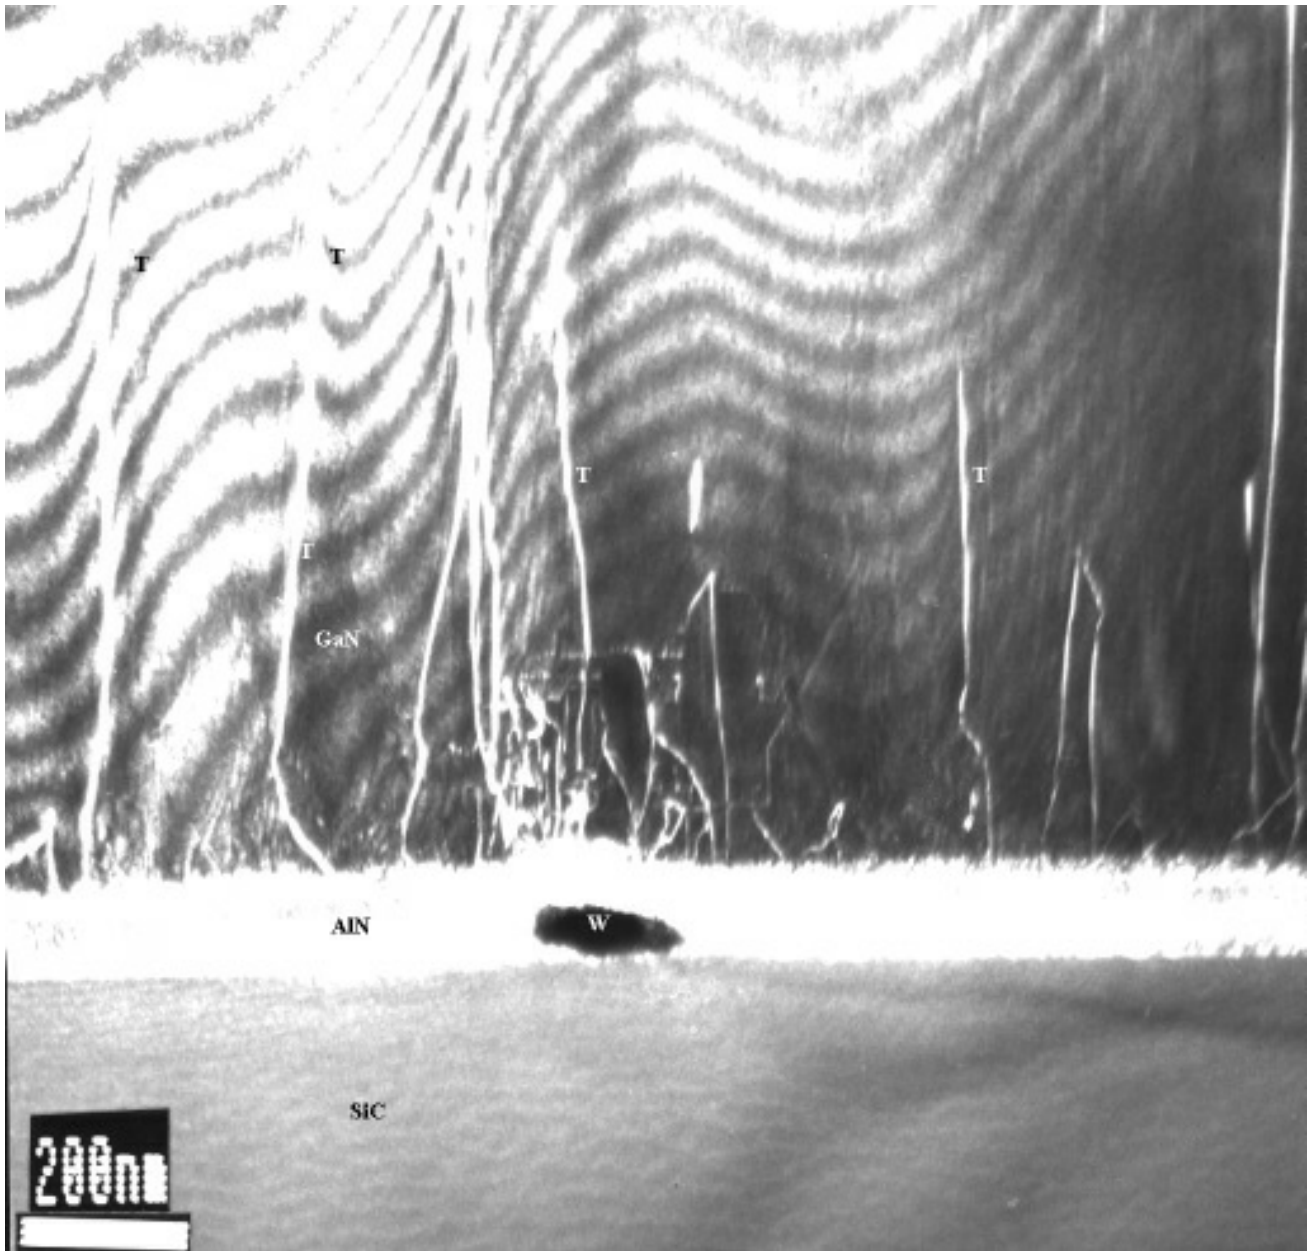
**Figure 6.** Precipitates at the SiC surface which originate in **c** and **a+c** dislocations.

substrate, some impurities have segregated during the high temperature step. They are W crystallites probably due to contamination from the W of the filament used for the 1300°C annealing, and on top of them, **c** or **a+c** threading dislocations originate (figure 6).
