The ground beneath their feet: building continuity at Neolithic Çukuriçi Höyük

Maxime Brami, Barbara Horejs and Felix Ostmann

Abstract

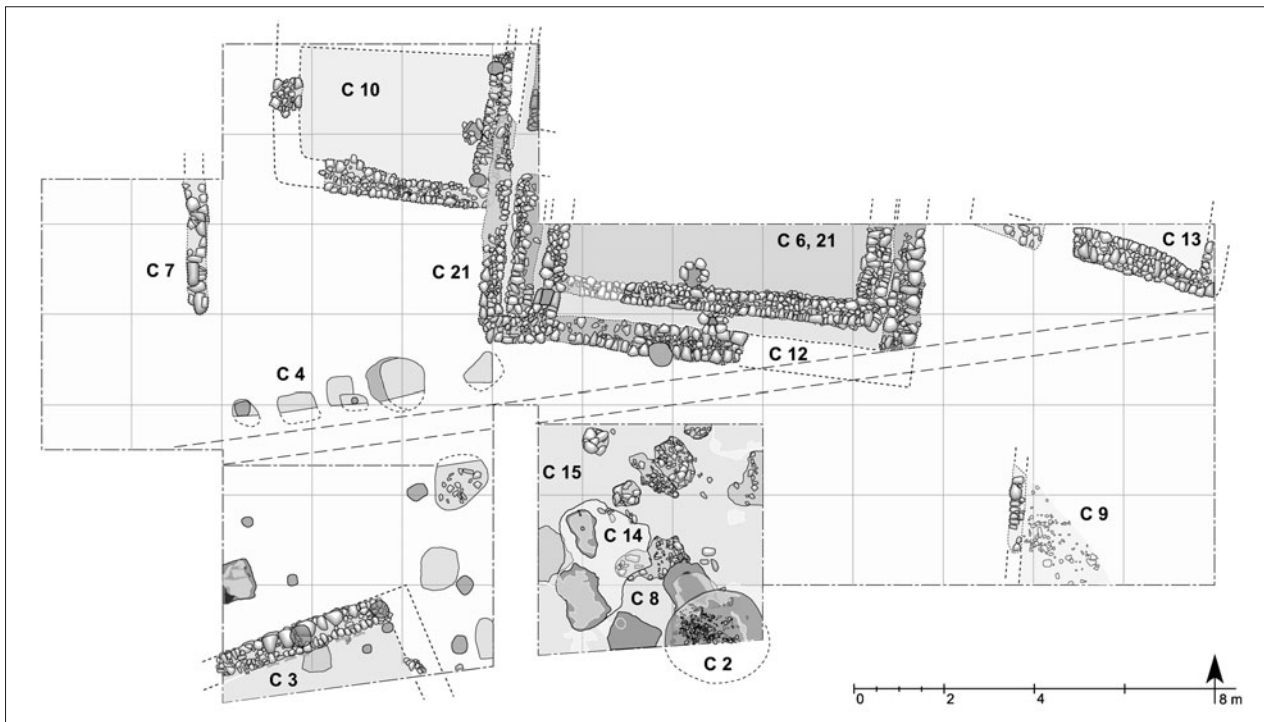
Fig. 2. Architectural remains of the Neolithic period, trench N6 (© Barbara Horejs; plan by M. Börner).

prime driver in the selection of this location (Ehlers et al. 2014). In total, a surface of 1,003m² has been exposed, yielding remains from the Neolithic to the Early Bronze Age. The northern side of the mound, which was cut away by a bulldozer, has produced well-preserved Neolithic levels, immediately concealed beneath the surface of the plain. The remains under discussion here stemmed from the northern excavation area, trench N6 (fig. 2).

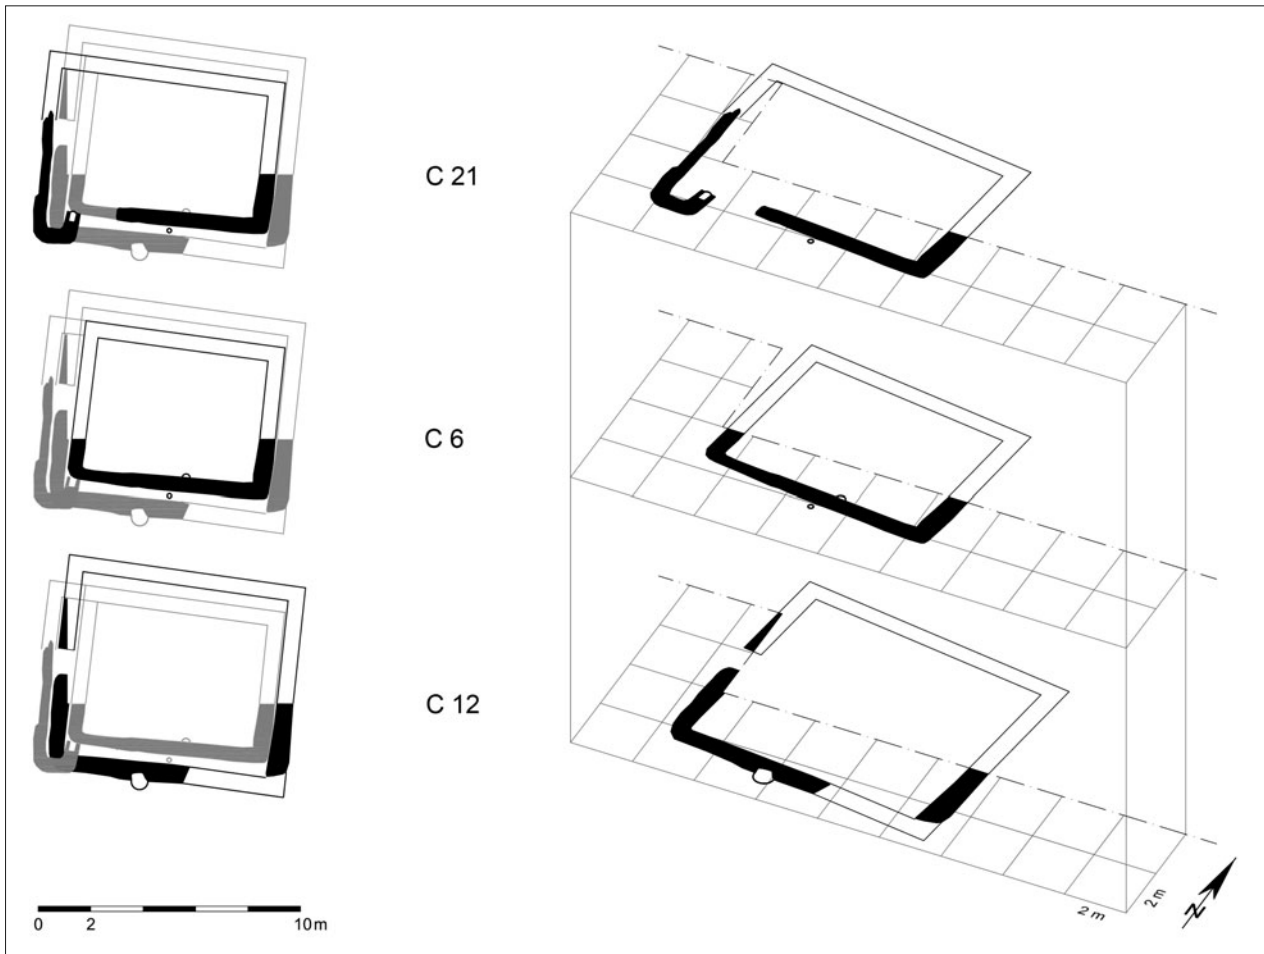
Fig. 3. Sequence of building replacement in trench N6, including, from top to bottom, Building C21, Building C6 and Building C12 (© Barbara Horejs; illustration by M. Börner).

The sequence of events leading to the stratification observed in trench N6 at Çukuriçi Höyük can be summarised as follows: Building C12 was the first building in a sequence of three vertically superimposed houses (from top to bottom, Building C21, Building C6

and Building C12; fig. 3). As a result of subsidence into a soil-filled feature, most likely an older ditch, Building C12 became unsafe and fell into disuse. Building C6 was subsequently inserted within the standing walls of Building C12, in such a way that new walls abutted – and presumably derived support from – old ones (fig. 4). This solution failed and Building C6 too sank into the ground. The abandonment of Building C6 is associated with a significant infilling event, which we regard as intentional. Building C21 was constructed upon the horizontally truncated fill, taking advantage of the stability of existing wall foundations, where possible, to erect new walls, and a doorway was created on the weakest load-bearing section of the building, presumably to relieve the weight placed upon it.

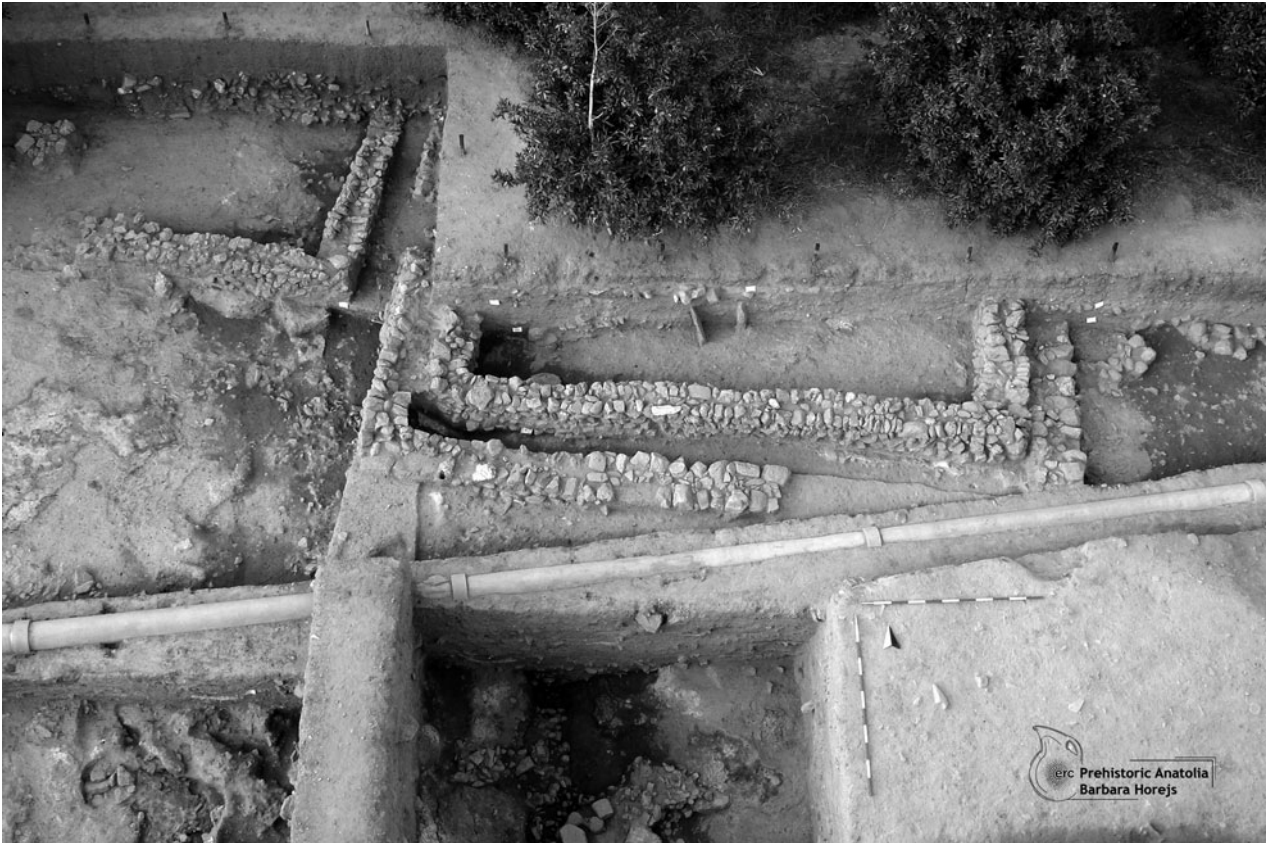
Fig. 4. Buildings C6 and C12, as seen from above (photograph by N. Gail).

The construction of Building C6 over the remains of Building C12 coincided with the deposition of a virtually sterile sandy infill and large rocks in the western part of the building, apparently to compensate for the declivity of the slope. Stratigraphically, it is not clear if this event was related to the closure of Building C12 or if, as we argue here, it initiated a new cycle of construction. A floor was laid over the former disturbance, which we assume to have been initially flat. Levelling activities involved clearing the upper sections of the walls of Building C12, just above the stone foundations. Spaces left in the wall by missing stones suggest that some were retrieved, presumably to be reused in the foundations of Building C6. The new building was constructed upon a raised fill, within the perimeter wall of the old one. Consequently, the building surface decreased to ca 7.7m by 5.8m. New walls rested

against the inner face of extant wall stumps on the eastern and western sides. On the southern side, a 0.4m-wide space was left between the Building C6 and Building C12 walls; this was filled with midden and covered with a lime-coated pebble floor or platform. Hence walls were doubled or tripled in thickness at the base. This heavy-duty structure was completed by two stone-lined postholes, one located against the middle of the southern wall inside Building C6 and the other in the narrow space between the Building C6 and Building C12 walls. It is not clear how the building was entered.

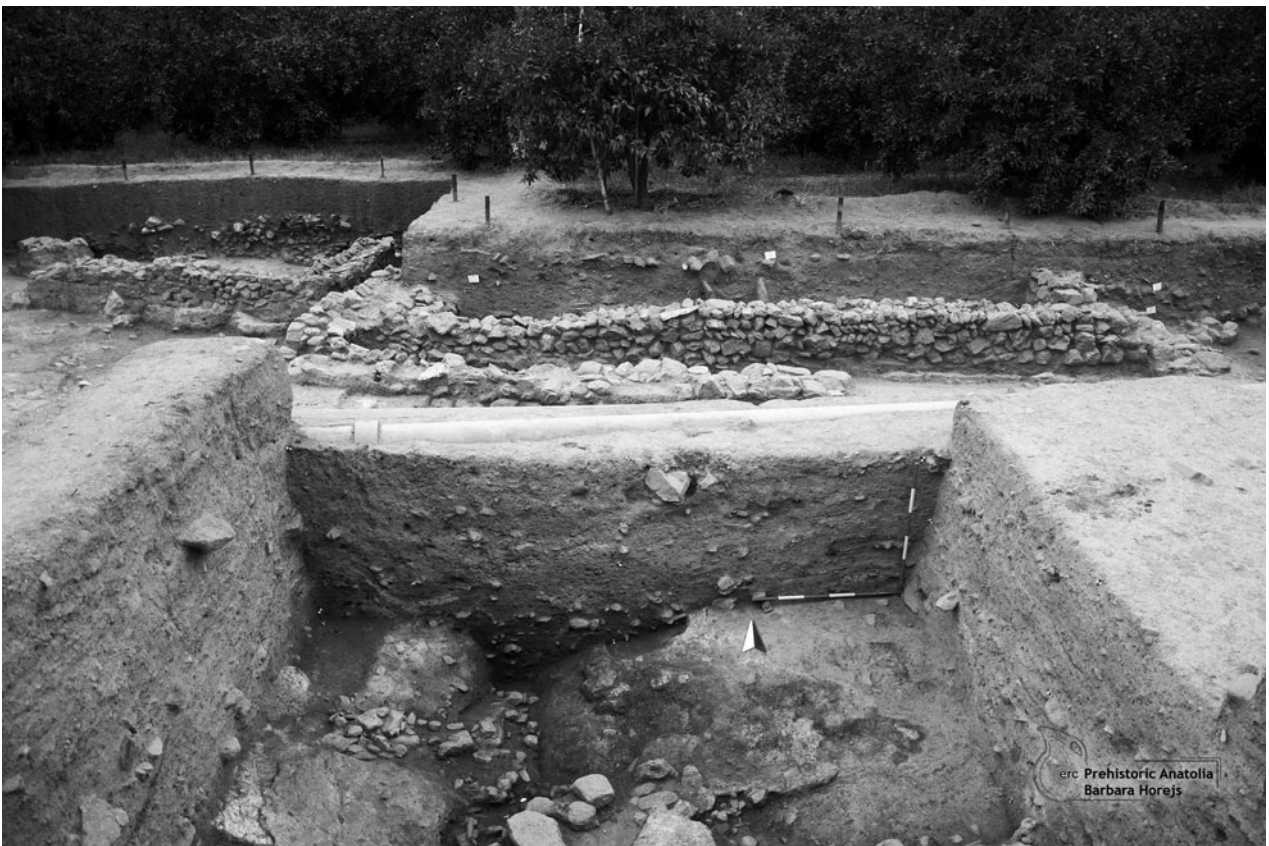
Fig. 5. Sloping surfaces underneath Buildings C6 and C12, as seen from the deep trench (photograph by F. Ostmann).

Although this architecture could potentially withstand considerable loads, it did not solve the problem of slumping described earlier. On the contrary, owing to its weight and its location, close to the fault's edge, the western wall of Building C6 sank deeper into the ground than that of Building C12. The lower section of the Building C6 wall can be seen to be leaning inward towards the centre of the room. This wall collapsed or was manually pulled apart at the end of the house's use-life, as indicated by upstanding slabs on the floor and abutting the

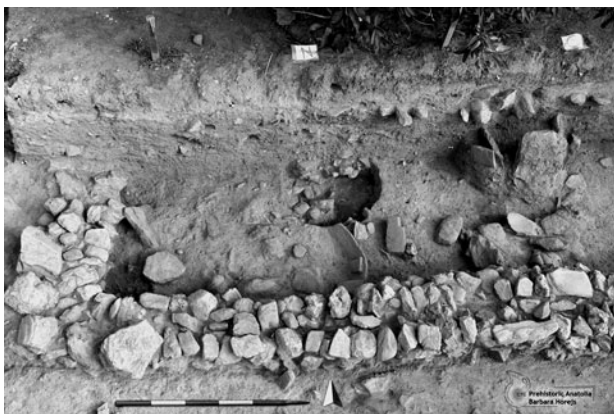
Fig. 6. Abandonment deposits in Building C6 (photograph by S. Bosch).

The abandonment of Building C6 was perhaps triggered by renewed subsidence and fissuring. Besides the aforementioned collapse (or manual demolition) of the western wall, there is evidence to suggest that the abandonment followed a structured sequence, including: (1) the deposition of complete animal bones, in particular scapulae, on the last floor surface and in a recess in the southwestern corner of the building; (2) the burial of the lower part of a vessel, associated with a visible accumulation of charcoal, in a shallow pit cut through the latest floor; and (3) the infilling with soil and stones of the house, up to the top of the stone wall stumps. The last step in the sequence is particularly noteworthy. It consisted of at least one major depositional event, encompassing over 650 litres of distinctive sandy clay deposit for this section of the building alone (fig. 6). Large rocks were deposited in the western half of the building, alongside a remarkable collection of artefacts (over 30) – most complete and in pristine condition – including polished stone axes/adzes, clay sling pellets, bone awls, spatulae and the only articulated Neolithic necklace ever recovered at the site, showing an alternation of red and black beads, 61 in total. Necklaces are usually associated with burials and people in the Anatolian Neolithic, raising questions about the

meaning of this artefact in an abandonment context. The location of the stones suggests they were placed there with the intention to level the uneven ground. In sum, it appears that Building C6 was deliberately infilled at the end of its use-life, both to achieve a form of (ritual) closure and to prepare the ground for a third superimposed house, Building C21.

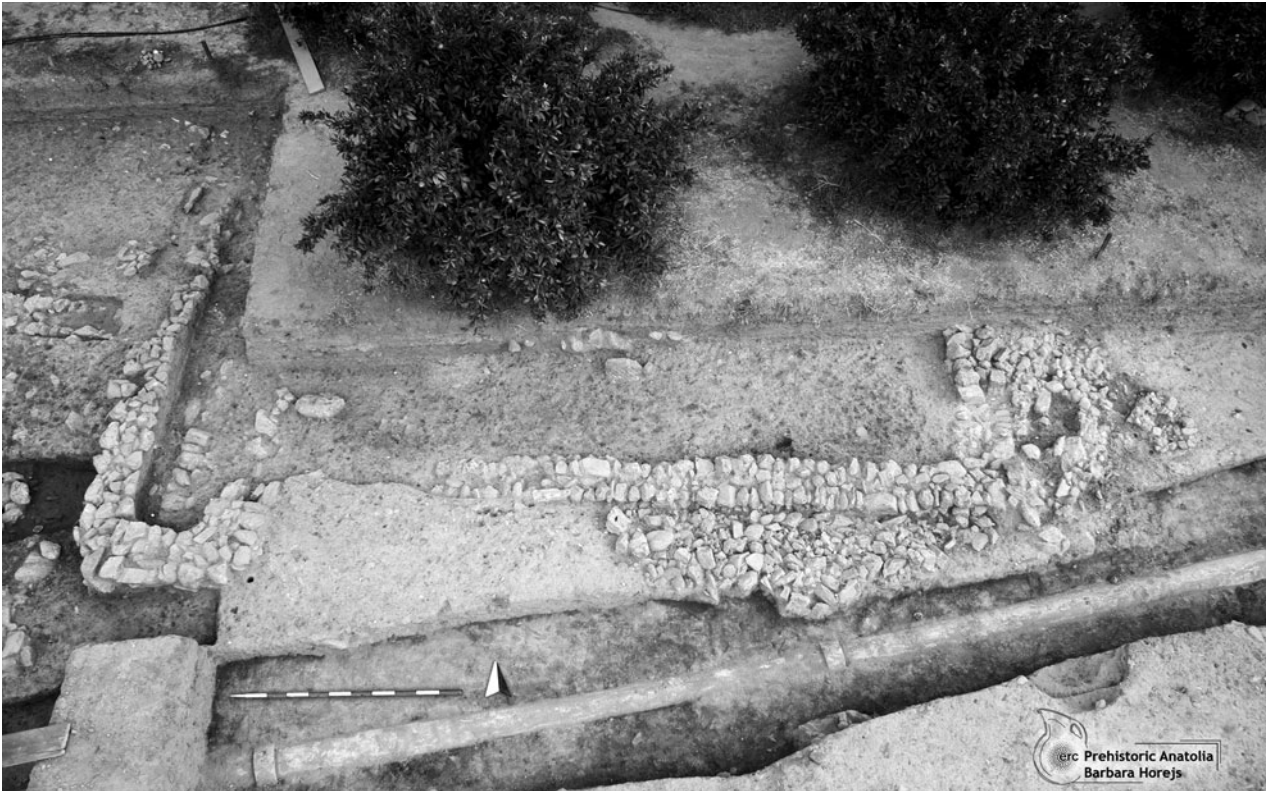
Fig. 7. Buildings C6 and C21, as seen from above (photograph by M. Börner).

The construction of Building C21 involved the horizontal truncation of the Building C6 fill, immediately below the last row of stones (fig. 7). In this case, none of the stones appear to have been recycled. The eastern wall of Building C6 was integrated into the foundations of the new structure and at least one additional row of stones was erected upon the top of the old wall, without an overhang (fig. 8). To the west, in contrast, the floor of Building C21 stretched over the wall stumps of Buildings C6 and C12, which were no longer visible, and a new wall was constructed on the outside, in such a way as to encircle the former two. With the extension, the building reached a size of ca 9.0m by 7.3m. Door-jamb slabs firmly set between the walls of Buildings C6 and C12 indicate that a large unbuilt section in the middle of the southern wall was probably used as a doorway. This arrangement solved at once two problems: (1) the reduction of the floor space with each reconstruction and (2) the recurrent slumping, which was strongly attenuated. While the stones in the underlying fill helped to shore up the building, the location of the doorway relieved some of the pressure placed on this section of the structure.

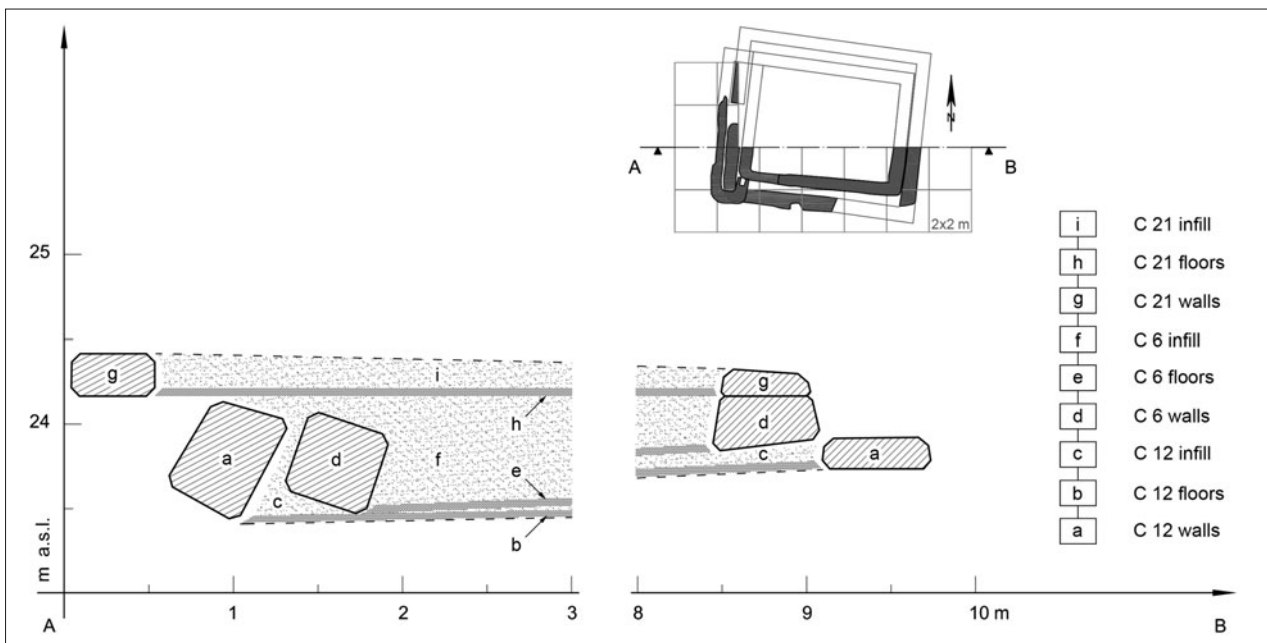
Fig. 8. Schematic section through the building sequence C6-C12-C21, as seen from the south (illustration by M. Börner).

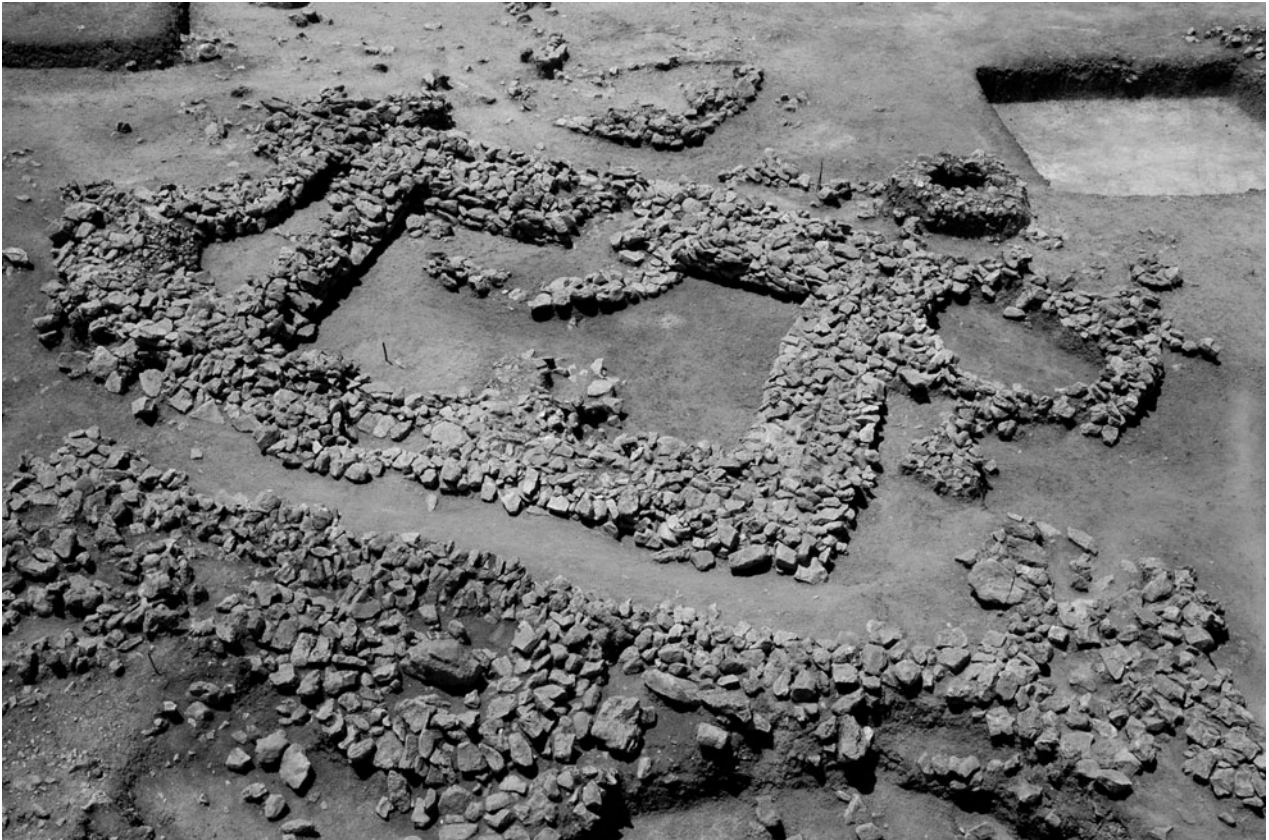
Fig. 9. Buildings DY1 and DY6, Ege Gubre (courtesy of the Ege Gubre Research Project).

The sequence of building replacement at Ege Gübre is particularly noteworthy. Once DY1 fell into disuse, a new building, DY6, was inserted within its upstanding walls, thus downsizing the habitation surface from ca 47.5m² to 28m² (Ozan 2012). New walls simply abutted old ones without replacing them, following a sequence similar to that outlined earlier for Çukuriçi Höyük (Buildings C6 and C12). DY6 was provided with a fireplace (hearth?), opposite the main doorway in the middle of the eastern wall (Ozan 2012). To the south, the DY6 wall was set back from the DY1 wall, leaving a small compartment between the two walls, which was presumably infilled, like the space between Buildings C12 and C6. DY1 and DY6
