RESEARCH ARTICLE

Potential damage threats to downstream optics caused by Gaussian mitigation pits on rear KDP surface

Hao Yang^{1,2†}, Jian Cheng^{1†}, Zhichao Liu², Qi Liu¹, Linjie Zhao¹, Chao Tan¹, Jian Wang², and Mingjun Chen¹

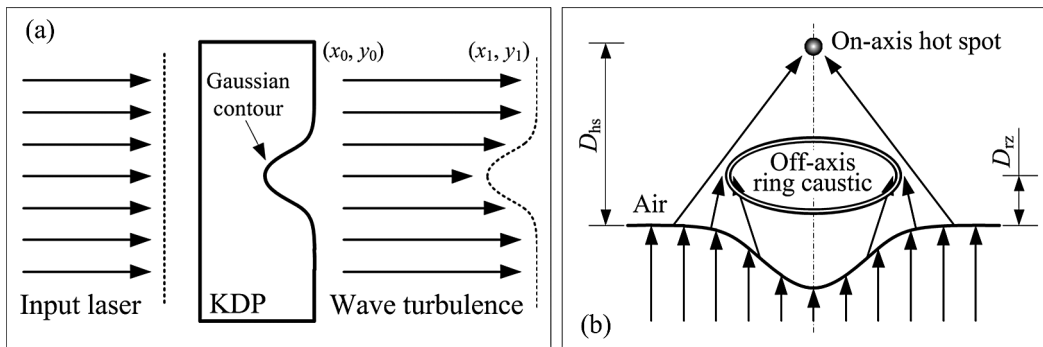
Figure 1. The effect of the Gaussian mitigation pit on the far-field propagation of the outgoing laser. (a) Sketch of the far-field modulation caused by the Gaussian mitigation contour on a KDP rear surface. (b) The relative positions of two dominant downstream light intensification patterns caused by the Gaussian mitigation pit on a KDP rear surface. D_{hs} and D_{rz} refer to the focal lengths of on-axis hot spot and off-axis ring caustic, respectively.

There would be light-field disturbance when the laser propagates in the downstream far field due to the presence of the repair morphology on the crystal surface. Figure 1(a) is a sketch of the far-field modulation caused by the Gaussian mitigation contour on a KDP rear surface. The normally incident plane wave is distorted in phase when it passes through a rear surface with a mitigation pit. After passing through the area, the light field possesses a wavefront with a particular shape. The wavefront phase (φ) distribution of the repaired region is characterized by

The diffraction effect of the downstream light field and the position of the light-intensity enhancement can be preliminarily analyzed by traditional geometric optics theory. Figure 1(b) shows the relative positions of two dominant downstream light intensification patterns caused by the Gaussian mitigation pit on a KDP rear surface. D_{hs} and D_{rz} refer to the focal lengths of on-axis hot spot and off-axis ring caustic, respectively. The off-axis ring caustic is mainly due to the arc contour around the Gaussian mitigation pit, which produces effects like a convex lens. The position of the on-axis hot spot appears relatively farther than that of the off-axis ring caustic. The hot spot is caused by the diffraction effect of uneven phase distribution of the outgoing light from the KDP rear surface.

off-axis ring caustic predicted theoretically in Figure 1(b). The light-intensity energy distribution of the diffracted bright region is, however, uneven. The maximum value of the light-intensity intensification is located at the center position of the corresponding Gaussian laser, and the energy at both sides is gradually attenuated. Combined with the above calculations of beam patterns provided by the small-spot Gaussian laser, the experimental results can be analyzed and discussed.

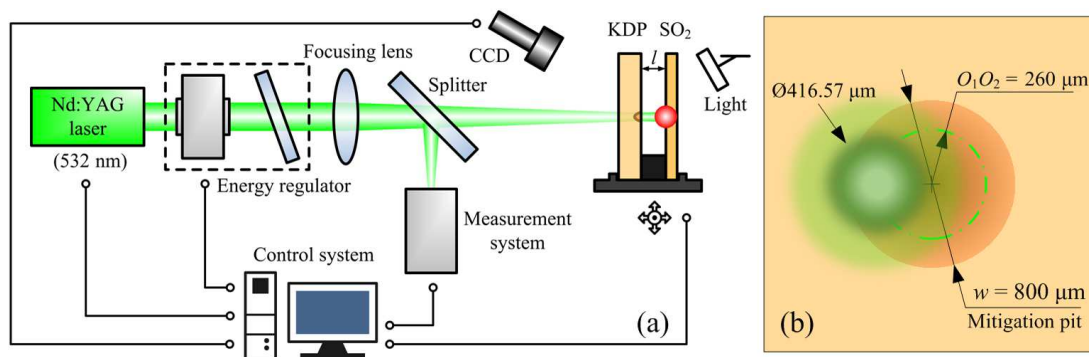
Figure 2. Laser damage test of a downstream fused silica component induced by a Gaussian mitigation pit on the KDP rear surface. (a) Optical path diagram of the laser damage experiment for downstream fused silica components. (b) Schematic of laser irradiation to a Gaussian mitigation pit on the rear surface of a KDP crystal.

Although the modulation can be derived by actually observing the light-intensity distribution downstream, the laser damage experiment on downstream fused silica more directly proves that the mitigated KDP surface can cause laser damage to downstream optical components. According to the results of laser damage tests for a Gaussian mitigation pit on a KDP rear surface and finished fused silica, the laser damage experiment on downstream optical components was designed. The experiment is based on the laser damage test platform for small aperture optical components. A loading table is added in the experimental system to ensure that the relative distance between the KDP crystal and downstream fused silica is 10 mm. A diagram of the optical path in the experiment is shown in Figure 2(a). The laser damage test for downstream fused silica optics is performed using a pulsed laser with wavelength of 532 nm, with a duration of 8.3 ns and a frequency of 1 Hz. The laser energy passes approximately parallel through the KDP crystal and fused

silica elements. The laser energy focused on the rear surface of the KDP crystal is Gaussian-shaped in space, and the effective spot diameter at the waist position is $416.57 \mu\text{m}$ ($1/e^2$). Since the Gaussian mitigation pit could not be completely illuminated by a single laser irradiation, a laser scanning method is employed. The Gaussian laser irradiation method for a Gaussian mitigation pit on the rear surface of KDP crystal is shown in Figure 2(b). The distance O_1O_2 between the center of the laser spot and the center of the Gaussian mitigation pit is $260 \mu\text{m}$. A single irradiation is applied to the top, bottom, left and right positions of the Gaussian mitigation pit. The center point of the Gaussian laser spot falls on the green circle in Figure 2(b). Since the small-spot Gaussian laser adopted in the experiments would cause a change of the modulation degree and the light distribution in the diffraction pattern relative to the large flat-top laser, the influence of the Gaussian laser and the flat-top laser on the downstream light-field propagation should be compared before discussion of the experimental results. During the experiment, it is necessary to guarantee the positional accuracy of the loading table and the output energy stability of the laser path. After laser irradiation, the laser damage site on fused silica was observed and analyzed by optical microscope.

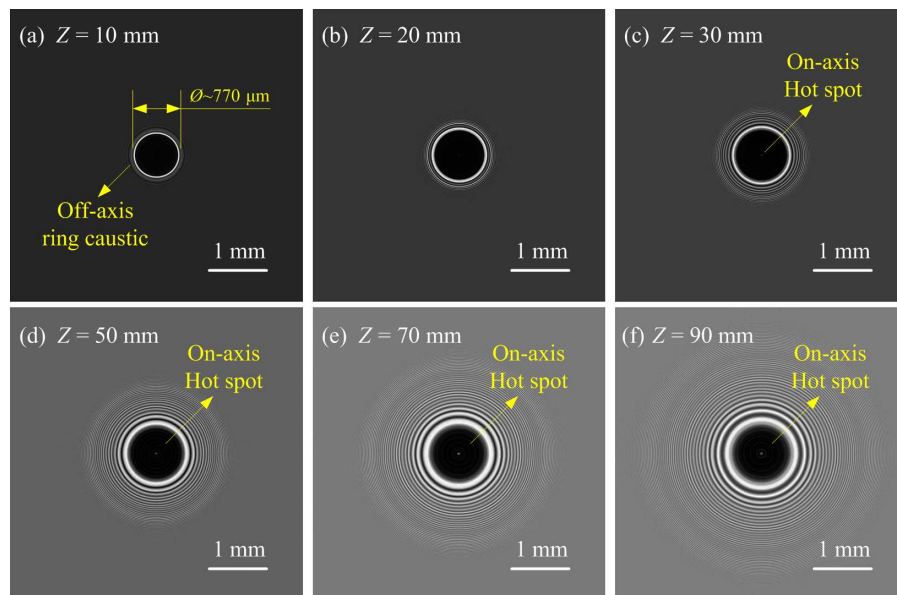
Figure 3. The far-field diffraction patterns caused by the Gaussian mitigation contour with a width of $800\ \mu\text{m}$ and a depth of $10\ \mu\text{m}$ at downstream distance of (a) $Z = 10\ \text{mm}$; (b) $Z = 20\ \text{mm}$; (c) $Z = 30\ \text{mm}$; (d) $Z = 50\ \text{mm}$; (e) $Z = 70\ \text{mm}$; (f) $Z = 90\ \text{mm}$.

Gaussian mitigation pits on the rear surface of KDP crystal would cause disturbance of incident laser propagation and obvious downstream diffraction phenomena accompanied by severe light-intensity enhancement at various distances from a KDP rear surface. Figure 3 shows the diffraction patterns at different downstream positions from the Gaussian mitigation pit on a KDP rear surface. A Gaussian mitigation pit with the fixed structural parameters of width $800 \mu\text{m}$ and depth $10 \mu\text{m}$ is adopted for calculation. With a diffraction distance

of 10 mm , the entire light almost converges on a bright string with a diameter of $\sim 770 \mu\text{m}$. Although there are several diffraction fringes, their relative light intensity is much lower than that of the brightest string. According to the theoretical analysis of the light-intensity enhancement in Section 2, it can be inferred that the brightest string is the off-axis ring caustic as shown in Figure 1(b). Due to the strong light intensification at the location of light convergence, there will be a significant threat to the normal use of downstream optical components. When the downstream position is 20 mm from the rear surface, the diffraction rings start to expand outward, and generate some second-brightest rings near the brightest one. This indicates that the focusing intensity has started to weaken, and the laser energy is gradually dispersed to the area around the focus. At a distance of 30 mm , a hot spot appears at the center of the diffraction pattern. Nevertheless, compared with the surrounding bright rings, the light intensification of the hot spot is much weaker. At this time, the off-axis ring caustic is still dominant in the light-field modulations. But the occurrence of the hot spot of the central light intensification verifies the diffraction effect caused by the uneven phase distribution in the theoretical analysis in Section 2. At a distance of 50 mm , not only the number of off-axis bright rings increases, but their relative light intensity also decreases significantly. The central hot spot area also becomes larger. When the distance from the rear surface is 90 mm , the light-intensity distribution of the diffraction pattern is similar to the case with 70 mm distance position. But the bright rings in the diffraction pattern at the $Z = 90 \text{ mm}$ position are larger than that of $Z = 70 \text{ mm}$. According to the overall evolution of diffraction patterns, the off-axis ring caustic appears first, and then gradually disperses into multiple bright rings as the distance from the rear surface increases. Meanwhile, the light intensification decreases slowly. The location of the on-axis hot spot appears behind the off-axis ring caustic (more than 30 mm away from the KDP rear surface). The hot spot area continues to grow as the distance increases, and the light-intensity enhancement may dominate at certain locations. The simulated patterns

enhancement reaches a maximum, which is mainly related to the energy accumulation produced by the off-axis ring caustic. Despite the generation of the on-axis hot spot in the diffraction pattern as shown in Figures 3(c)–3(f), the light-intensity enhancement does not maintain a high level as the off-axis ring caustic fades. The Gaussian mitigation pits on fused silica, however, produce a secondary intensity enhancement peak at a distance from the rear surface of the fused silica component. Due to the repair principle of CO_2 laser irradiation and the material removal mechanisms of melting and evaporation for fused silica components, a raised rim is formed around the repaired profile, resulting in an increase in far-field focused spot energy.

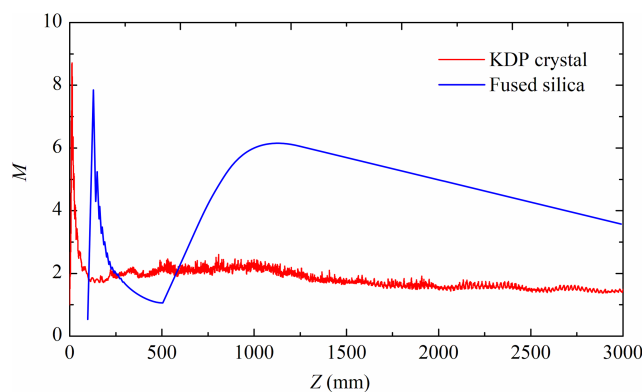
Figure 4. Comparison of the downstream light-field modulations between the Gaussian mitigation pits on KDP crystal and fused silica.

Figure 4 shows the downstream light-field modulations caused by the Gaussian mitigation pits on KDP crystal and fused silica. The red line in Figure 4 represents the evolution of light-field modulations calculated by the KDP crystal model in Section 2. The blue line corresponds to downstream light-field modulations of fused silica, which are reported by Bai *et al.*^[21]. There is a big difference between these two cases. The downstream light-intensity enhancement caused by the mitigation pit on the KDP crystal increases sharply, then decreases rapidly, and eventually keeps stable with the increase of light-propagation distance. At a position of $\sim 10\ \text{mm}$ from the KDP rear surface, the light-intensity

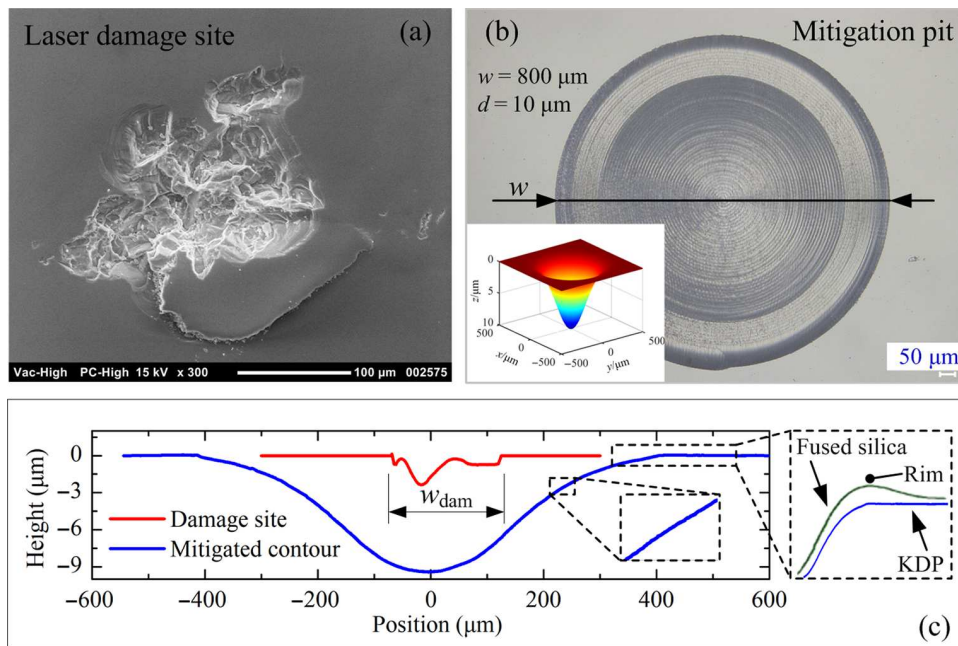
Figure 5. Microscopic morphology of laser damage and Gaussian mitigation profile. (a) SEM image of a laser damage site on the surface of a KDP crystal. (b) Optical micrograph of a KDP surface with a Gaussian mitigation pit. The inset is the three-dimensional shape of the Gaussian mitigation pit with a width of $800 \mu\text{m}$ and a depth of $10 \mu\text{m}$. (c) Two-dimensional profile of the Gaussian mitigation pit and the damage site. The first inset is the local enhanced image. The second inset shows the edge profile of the mitigated KDP contour and the mitigated fused silica contour.

KDP crystals inevitably undergo laser-induced damage (LID) under high power laser irradiation. Figure 5(a) is a scanning electron microscope (SEM) image of the laser damage site on a crystal surface after laser irradiation at a wavelength of $355\ \text{nm}$, duration $3\ \text{ns}$ and fluence $8\ \text{J}/\text{cm}^2$. The size of the laser damage site would sharply become larger under subsequent laser irradiation.

Figure 5(b) shows an optical micrograph of the KDP surface with a Gaussian mitigation pit after the micro-milling processes. The inset is the three-dimensional shape of the Gaussian mitigation pit with a width of $800\ \mu\text{m}$ and a depth of $10\ \mu\text{m}$. The material near the surface defects of the KDP crystal is removed and substituted with the designed mitigation contours. The repaired crystal surface is regular, smooth and neat, with a surface roughness better than $30\ \text{nm}$. The relative transmittance of the repaired crystal surface is

greater than 95% compared with that of a diamond fly-cut KDP surface. Figure 5(c) is the two-dimensional profile of the Gaussian mitigation pit and the damage site. The damage site on the crystal surface is completely enveloped by the repaired contour. The inset of the local enhanced image shows that even at the waist where the slope changes the most, the repair surface remains smooth. Due to the different processing methods for surface repair on KDP crystal and fused silica, the surrounding raised rim would be produced on the edge contour of the mitigated fused silica surface, which can be seen in the second inset. This rim is formed from the mass movement of silica at high temperatures from the low viscosity central region outwards during CW- CO_2 laser processing, and can be several microns high. The micro-mechanical method is utilized to repair the KDP surface, however. The repair process is more controllable and there is no rim similar to the fused silica on the edge of the mitigated KDP contour. Thus, the Gaussian mitigation pit in the model can fully describe the repaired contour.

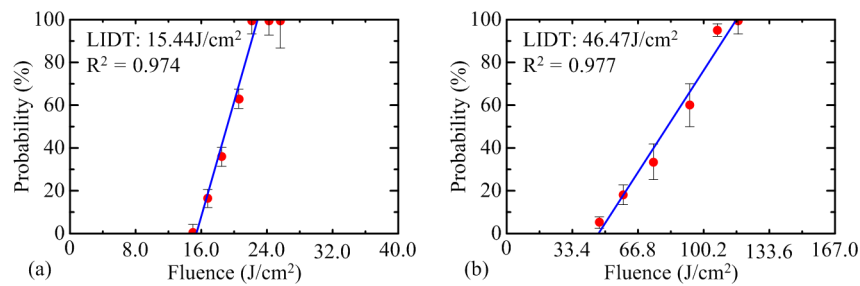
Figure 6. LIDTs for the Gaussian mitigation pit on (a) the KDP rear surface and (b) the front surface of fused silica.

The LIDTs are tested to provide a reliable data reference for laser damage experiments for downstream optical components caused by mitigation pits on an upstream KDP rear surface. Figure 6 shows the LIDTs for a Gaussian mitigation pit on a KDP rear surface and a front surface of fused silica. Their LIDTs were 15.44 J/cm^2 and 46.47 J/cm^2 ,

respectively, with a coefficient of determination of 0.974 and 0.977, respectively. The R^2 of the fitting curve on LIDT is close to 1, indicating that the test results for LIDTs are credible. The key of the experiment is to observe changes in the downstream fused silica components while ensuring that no damage occurred in the laser-irradiated area of the KDP crystal. Therefore, the applied fluence of a single laser irradiation is 10 J/cm^2 , which is absolutely safe for repaired KDP crystals.

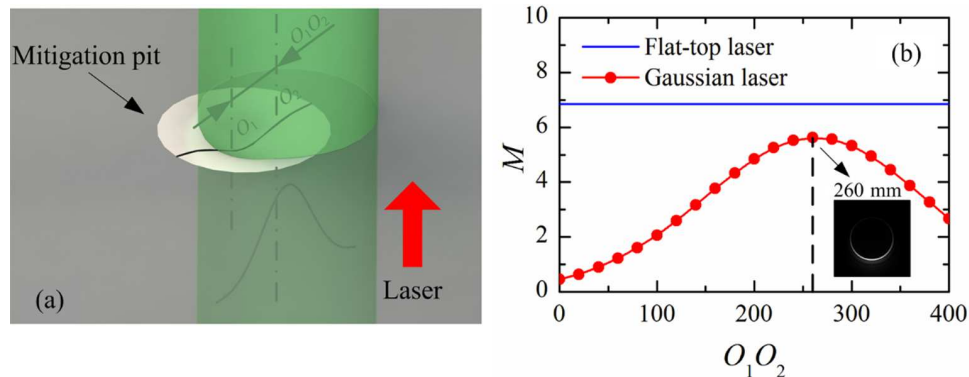
Figure 7. Comparison of the downstream light-field modulations caused by a Gaussian mitigation pit on the KDP rear surface with irradiation by flat-top laser and Gaussian laser. (a) Simulation schematic of light propagation when the KDP rear surface with mitigation pit is irradiated by incident laser. (b) Comparison of the light-field modulation generated by the flat-top laser and the Gaussian laser at a position 10 mm downstream. The inset is a diffraction pattern produced by a Gaussian laser at a position 10 mm downstream away from the crystal surface with a mitigation pit when the center point distance O_1O_2 is 260 mm.

In Section 3 the mitigation pit is irradiated by a small-spot pulse laser with a spatial energy distribution of Gaussian profile. Therefore the influence of the Gaussian laser and the flat-top laser on the downstream light-field propagation is compared first. Figure 7(a) shows a simulation schematic of light propagation when the KDP rear surface with mitigation pit is irradiated by a Gaussian laser. The distance between the center positions of the Gaussian laser spot and the Gaussian mitigation pit is assumed to be O_1O_2 . The laser with spatial energy distribution of Gaussian shape and wavelength of 532 nm transmits from the rear surface of the crystal. The effective diameter of the laser spot for the calculation is consistent with the experimentally applied laser spot size ($416.57 \mu\text{m}$), which is close to the waist diameter of the repaired Gaussian contour. In order to find the effect of the spatial position of the laser spot on light diffraction, the

light-field modulations corresponding to various distances O_1O_2 are calculated. Figure 7(b) is a comparison of the light-field modulation generated by the flat-top laser and the Gaussian laser at the position 10 mm downstream from the Gaussian mitigation pit on the KDP rear surface, where the blue and red lines indicate the variations of light-field modulation with respect to the distance O_1O_2 , respectively. The blue line is parallel to the coordinate axis of O_1O_2 , and the corresponding value on the ordinate axis of light-field modulation is almost constant at 6.85, which indicates that the light-field modulation at the position 10 mm from the rear surface of the crystal does not change when the position of the flat-top laser moves away from the center of the Gaussian mitigation contour. For crystals irradiated by a Gaussian laser, however, the downstream light-field modulation tends to first increase and then decrease with the increase of O_1O_2 . The red line is obtained by fitting a series of calculated results, and the overall appearance is a two-dimensional Gaussian shape. At the position $O_1O_2 = 260$ mm, the curve reaches the highest point, and the corresponding modulation degree M is 5.63, which is slightly smaller than that under the condition of flat-top laser irradiation. When the center point distance O_1O_2 is 260 mm, the light-field diffraction pattern at the position 10 mm downstream is shown in the inset in Figure 7(b). The bright region in the diffraction pattern is generally annular in shape, similar to the

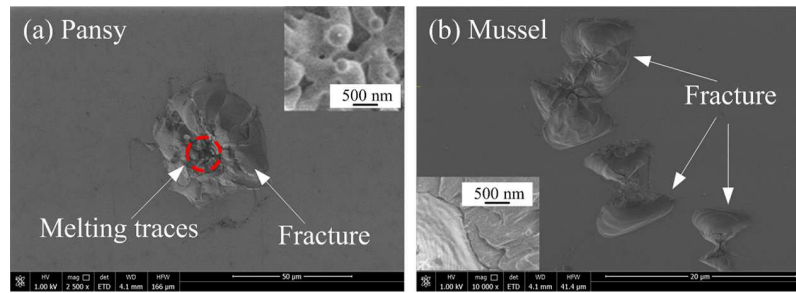
Figure 8. Microscopic morphology of the laser damage sites on downstream fused silica surface observed by SEM. (a) Pansy damage site; (b) mussel damage sites.

When the Gaussian mitigation pit on the rear surface of the crystal is exposed to laser irradiation, a plasma flash in the local area can be observed by the CCD. After the laser damage experiment, the surface of the downstream fused silica optics was examined using microscopy. The SEM micrographs of the laser damage sites on a fused silica surface are shown in Figure 8. The laser damage morphology can be divided into ‘pansy’ (in Figure 8(a)) and ‘mussel’ (in Figure 8(b)) forms, which are similar to the typical damage morphology reported by Carr *et al.*^[22,23] and Wong *et al.*^[24]. There would be some melting traces in the center and fracture region around the pansy damage site. The inset in Figure 8(a) shows the microscopic morphology of solidification material after melting. The mussel damage sites are mainly caused by fracture. The inset in Figure 8(b) shows the fracture surface of the KDP surface. The evidence of the damage sites proved that the Gaussian mitigation pit

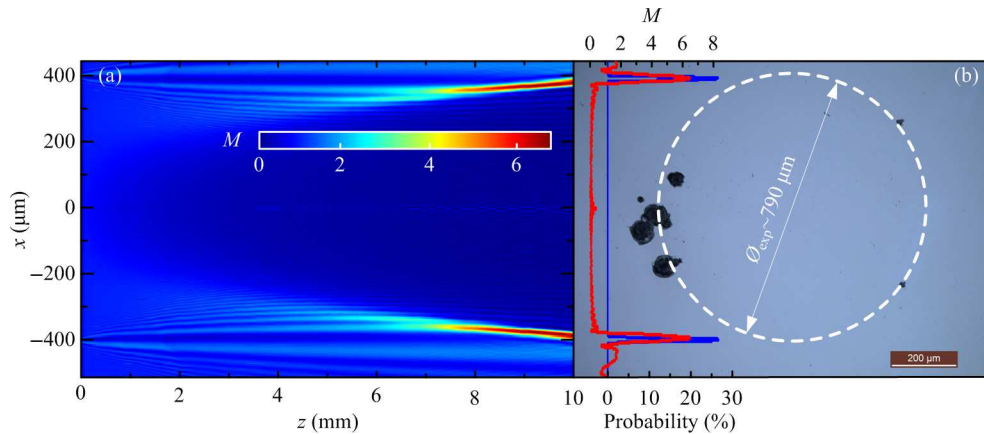
Figure 9. Comparison between the calculations and experiments. (a) Two-dimensional distribution of downstream light-field modulation along the laser propagation (z -axis) caused by the Gaussian mitigation pit on the rear surface of a KDP crystal. (b) Optical micrograph of laser damage morphology on downstream fused silica components.

Figures 9(a) and 9(b) are a comparison between the simulations and experiments for laser damage of downstream optical components, respectively. The simulation results show that due to the influence of the mitigation pit on the KDP rear surface on the phase of the transmitted light wave, a local dark field appears at the center of the downstream light field behind the repaired area. There is, however, a significant enhancement in light intensity on both sides of the central axis due to the laser diffraction effect, and the light-field modulation is more than 6 at the position 10 mm downstream. The one-dimensional distribution of light-field modulation at this position along the x direction is shown by the red line in Figure 9(b), and the peaks on both sides correspond to the position of the off-axis ring caustic as shown in Figure 3(a), with an equivalent diameter of $\sim 770 \mu\text{m}$. The blue line in Figure 9(b) is the theoretical probability distribution of laser damage on downstream fused silica at a distance of 10 mm from the KDP rear surface when the center of the Gaussian laser irradiates along the green ring in Figure 2(b). The probability of laser damage is $\sim 20\%$ in the ring region with a diameter of $770 \mu\text{m}$ and a

center point located at the center of the Gaussian mitigation contour. Observing the microscopic morphology of laser damage sites on fused silica, it is found that although the laser damage locations are unevenly distributed, they are all on the same circumference. There are a large number of laser damage sites on the left side of the micrograph, and only a small number of sporadic damage sites are distributed on the right side. The center of the laser spot is on the ring with a diameter of $540 \mu\text{m}$, but the damage position is on the ring with a diameter of $790 \mu\text{m}$, which is not located at the maximum energy region of the Gaussian laser. The error is less than 3% compared to the simulation result of $770 \mu\text{m}$. The laser damage area on the ring is about 20%–25% of the total area of the ring, which is close to the simulation results for laser damage probability. The comparisons above between the simulations and the experiments prove the validity of the model. This also verifies from the opposite side that the theory and method of the laser damage experiment for downstream optical components are reasonable and correct. In general, simulation and experimental methods can strongly prove the modulation effect of the mitigation pit on the downstream light field, which needs to be considered in advance during the surface repair of crystals as well as the installation process.
